Airborne Thermal Infrared Remote Sensing Salmon River Basin, California

Survey Date: July 22-23, 2009
Delivery Date: January 8, 2010

In 2009, the Salmon River Restoration Council contracted with Watershed Sciences, Inc. to provide thermal infrared (TIR) imagery for approximately 85 river miles in the Salmon River Basin. The TIR acquisition included the mainstem Salmon River, North Fork Salmon River and the South Fork Salmon River (*Figure 1, Table 1*). True color image frames were co-acquired along the flight path.

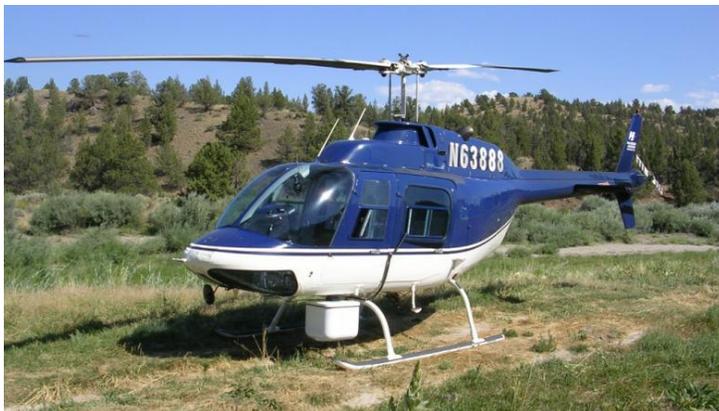
Figure 2 – Bell Jet Ranger equipped with a thermal infrared radiometer. The sensor is contained in a composite fiber enclosure attached to the underside of the helicopter and flown longitudinally along the stream channel.

Instrumentation: Images were collected with a FLIR system's SC6000 sensor (8-9.2 μ m) mounted on the underside of a Bell Jet Ranger Helicopter (*Figure 2*). The SC6000 is a calibrated radiometer with internal non-uniformity correction and drift compensation. General specifications of the thermal infrared sensor are listed in Table 2. The natural color images were collected with a Nikon D2X 12.4 Megapixel digital SLR camera with 30mm lens that was co-located with the TIR sensor.

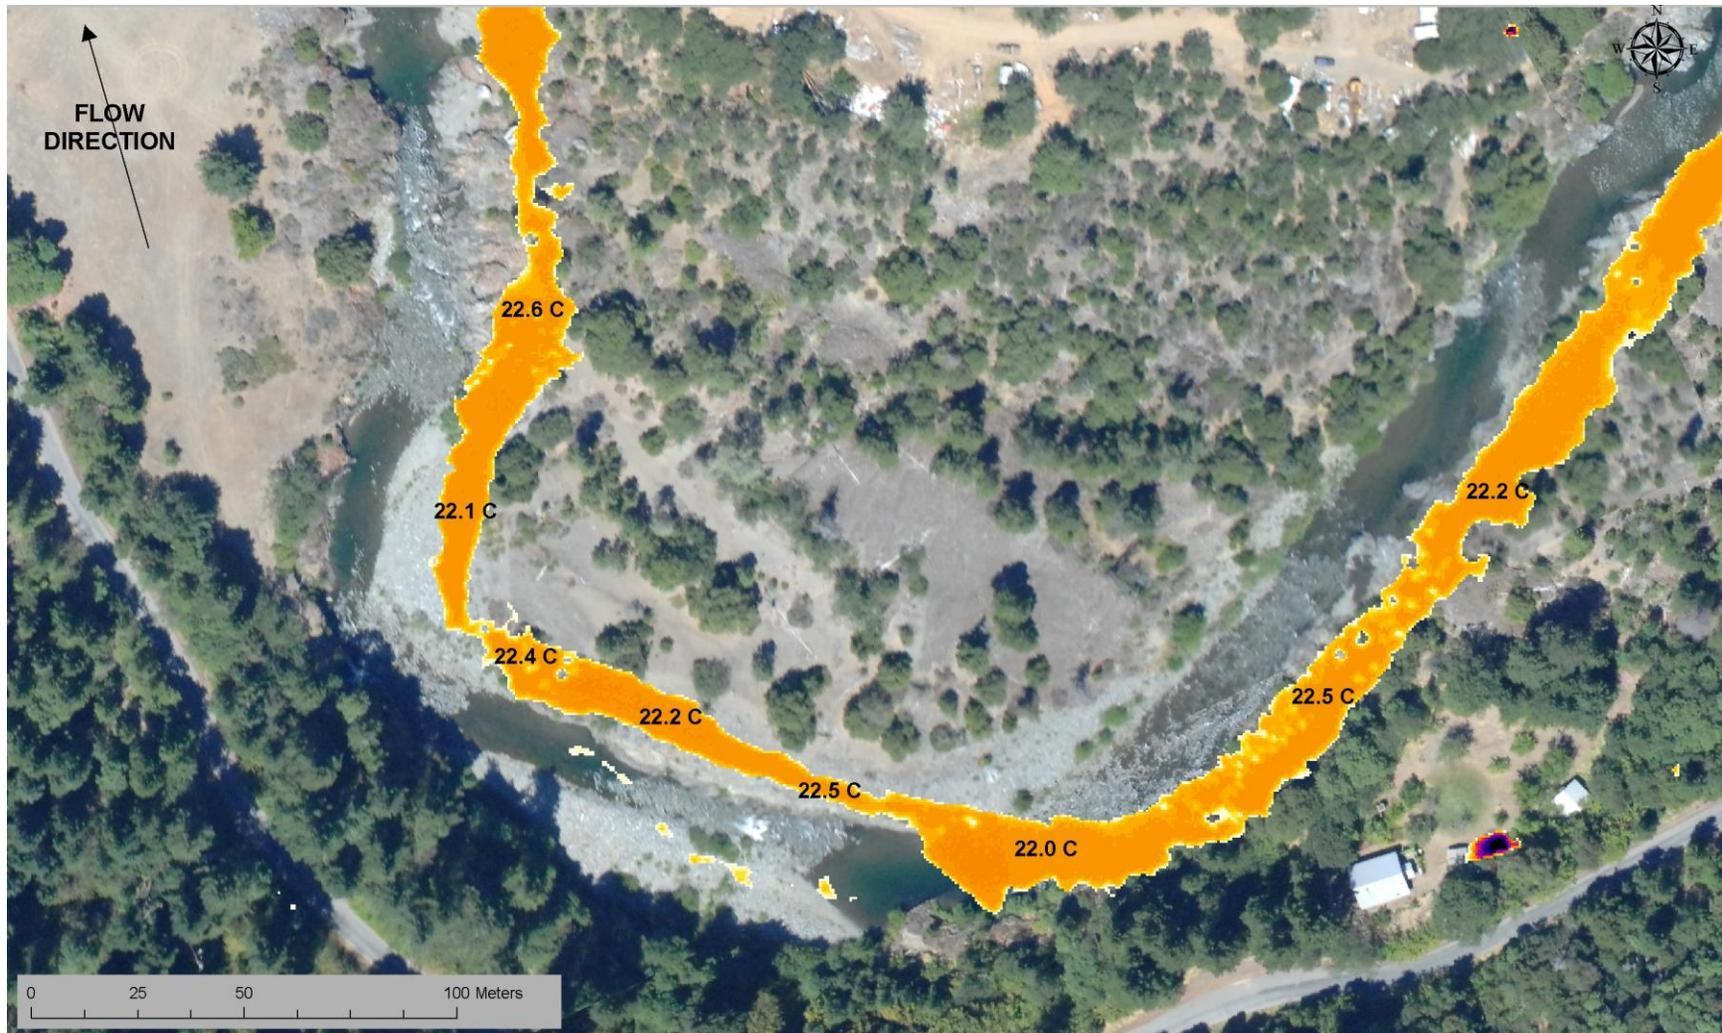
South Fork Image 2 – The TIR/true color image pair at river mile 0.58 shows the type of variability seen in pool/riffle sequences.. The images are offset in order to show the location of the pools and riffles in the true color imagery.

Some of the local spatial variability observed in this profile appears to be due to differences in pool/riffle sequences along the South Fork. Torgersen et al.³ documented a potential 0.5°C radiant temperature variability between pools and riffles due to differences in spectral versus diffuse reflectance at the water surface (pool versus riffle). The experience of Watershed Sciences, Inc. over the past ten years confirms this observation, but the level of variability depends on the sensor wavelength and observation angle (*South Fork Image 2*).
