# **Red Bank Off-Channel Fisheries and Riparian Habitat Enhancement Project**

**2024 Annual Monitoring Memorandum**  
**Reporting Period: January 2024-December 2024**  
**Submitted: May 2025**

Prepared by:  
**Salmon River Restoration Council**  
PO BOX 1089  
Sawyers Bar, CA 96027

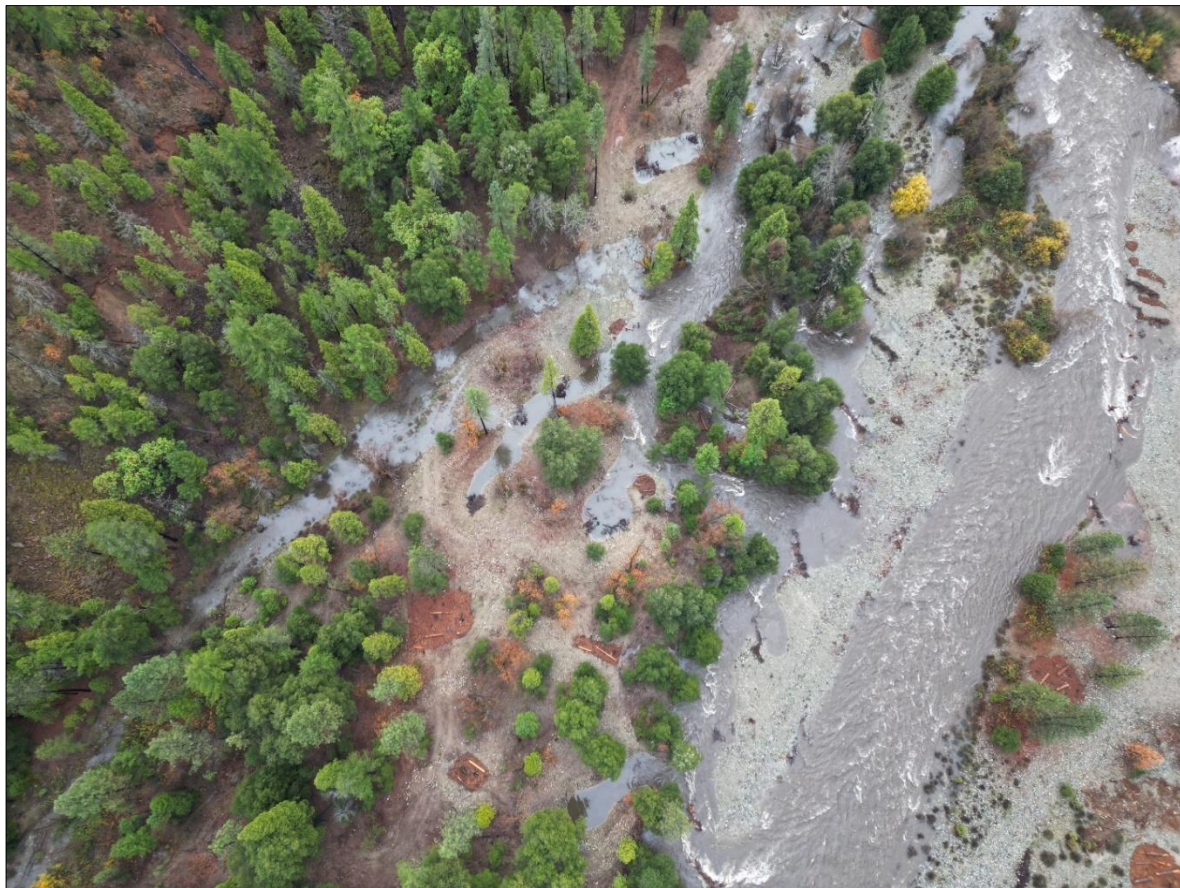
**Image 8:** High flows on November 22<sup>nd</sup>, 2024 fully engaged project features and provided velocity refugia throughout the site. Aerial photo of the Primary Side Channel (on right) and the Far Side Channel (center) with Backwaters 4, 5, 6, 7, and 8 visible at approximately 20,900 CFS at the Salmon River gage on its descent after a peak of 21,700 CFS.

In 2024, during the winter following phase two of construction, three significant flows events occurred; the first on November 22<sup>nd</sup> peaked at 22,700 CFS, and the second on December 24<sup>th</sup> peaked at 14,800 CFS, and the third on December 29<sup>th</sup>, 2024 peaked at 32,400 CFS. During these events, the river fully engaged the Red Bank project site, including the Primary Side, Far Side, Mid and Perennial Channels, and all Backwaters (Objective 2). The Perennial Channel remained perennial throughout the entire monitoring year (Objectives 1 & 2), all other features were dry by July 2024, and remained so during peak river temperatures.

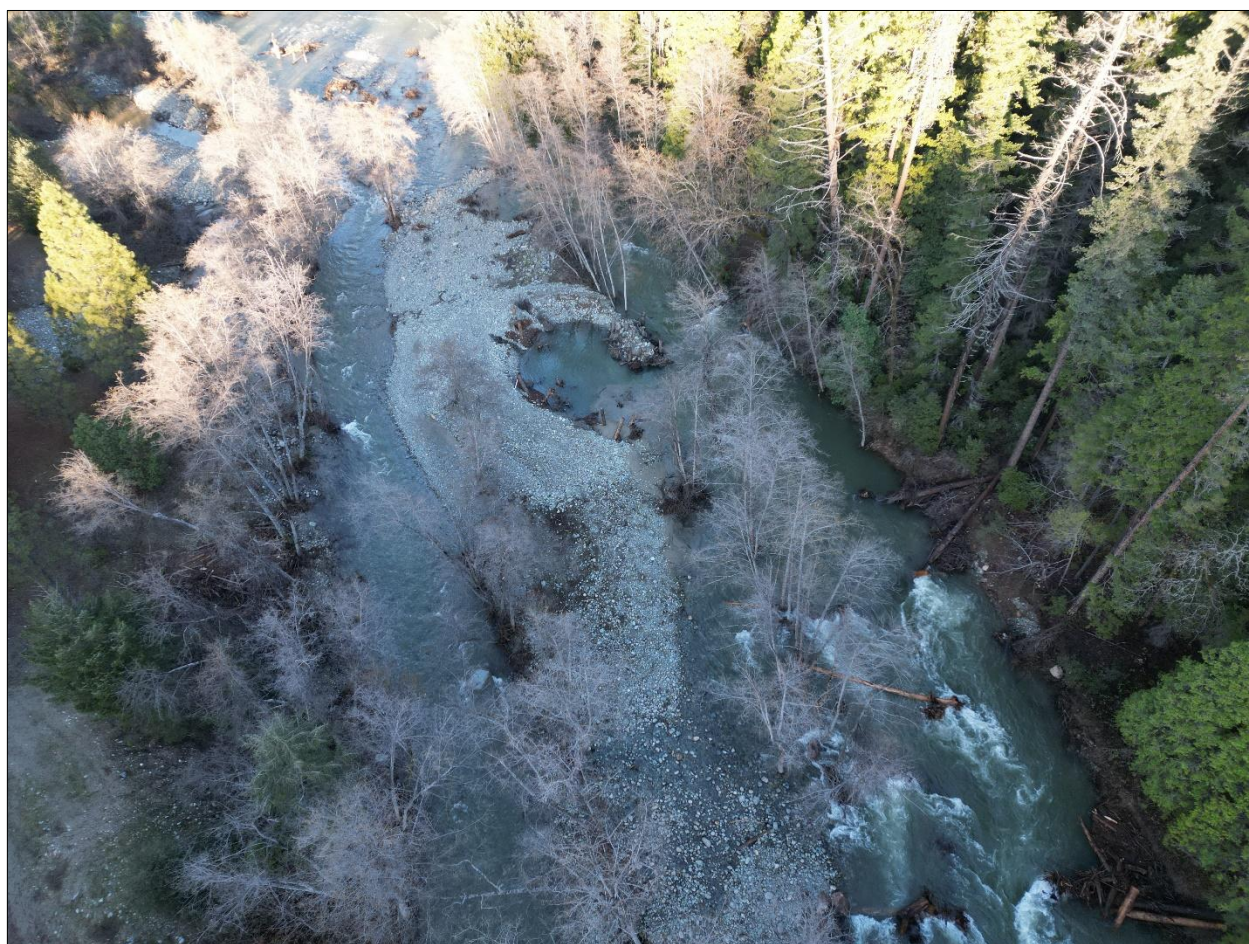
**Image 10 (above):** High flows on December 30<sup>th</sup>, 2024 engaged project features and provided velocity refugia throughout the site. Note the still water in the abutment jam alcove at center. Aerial photo at approximately 16,000 CFS at the Salmon River USGS gage.

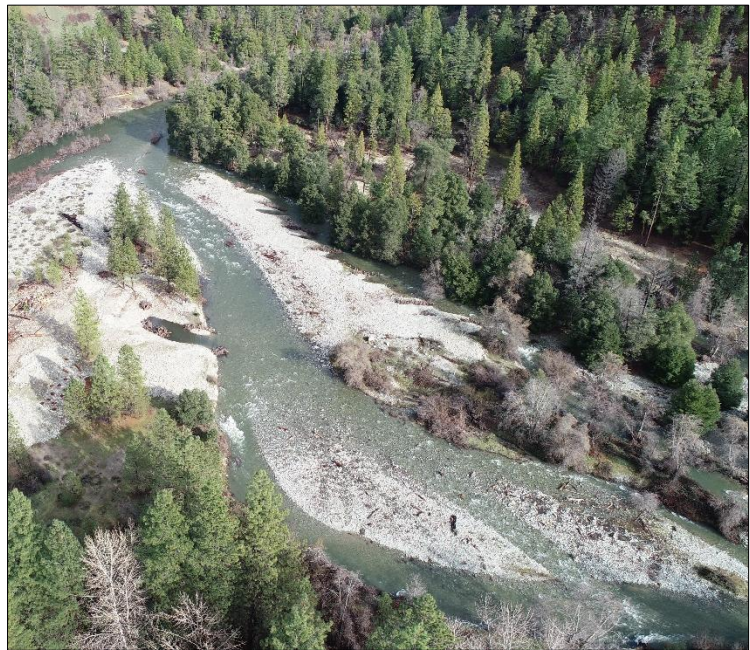
**Image 14 (above):** Aerial image of the Primary Side Channel post-phase one implementation, as the hydrograph was descending, around 10,000 CFS (at the USGS gage) on January 14<sup>th</sup>, 2024.

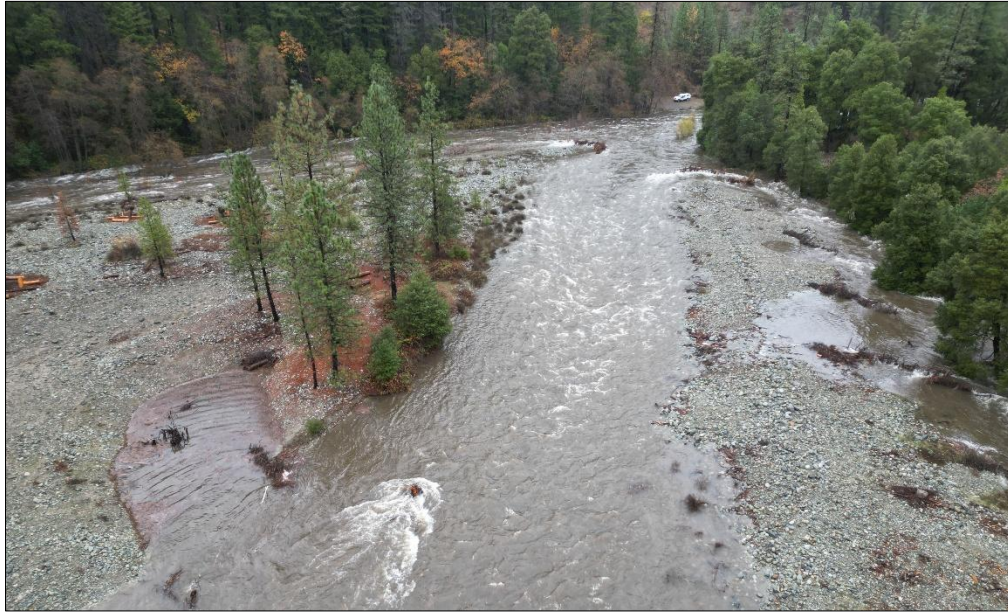
**Image 15 (above):** Primary Side Channel activated in the first high flow event post-phase two (facing upstream). Photo from November 22<sup>nd</sup>, 2024 as the hydrograph was ascending, at approximately 20,900 CFS (at the USGS gage).

The Primary Side Channel was designed to engage at winter base flow (20% exceedance), which is the equivalent of approximately 2,800 CFS at the Somes Bar USGS gage. Thus, the feature was engaged as expected immediately following the November 21<sup>st</sup>, 2024 storm event (see Image 15). The channel then reactivated on December 13<sup>th</sup>, 2024 around approximately 2,000 CFS, following a small series of winter storms. The engineered log jams and design-built fill plug mid-bar functioned as expected and prevented flow from eating into the western portion of the bar.

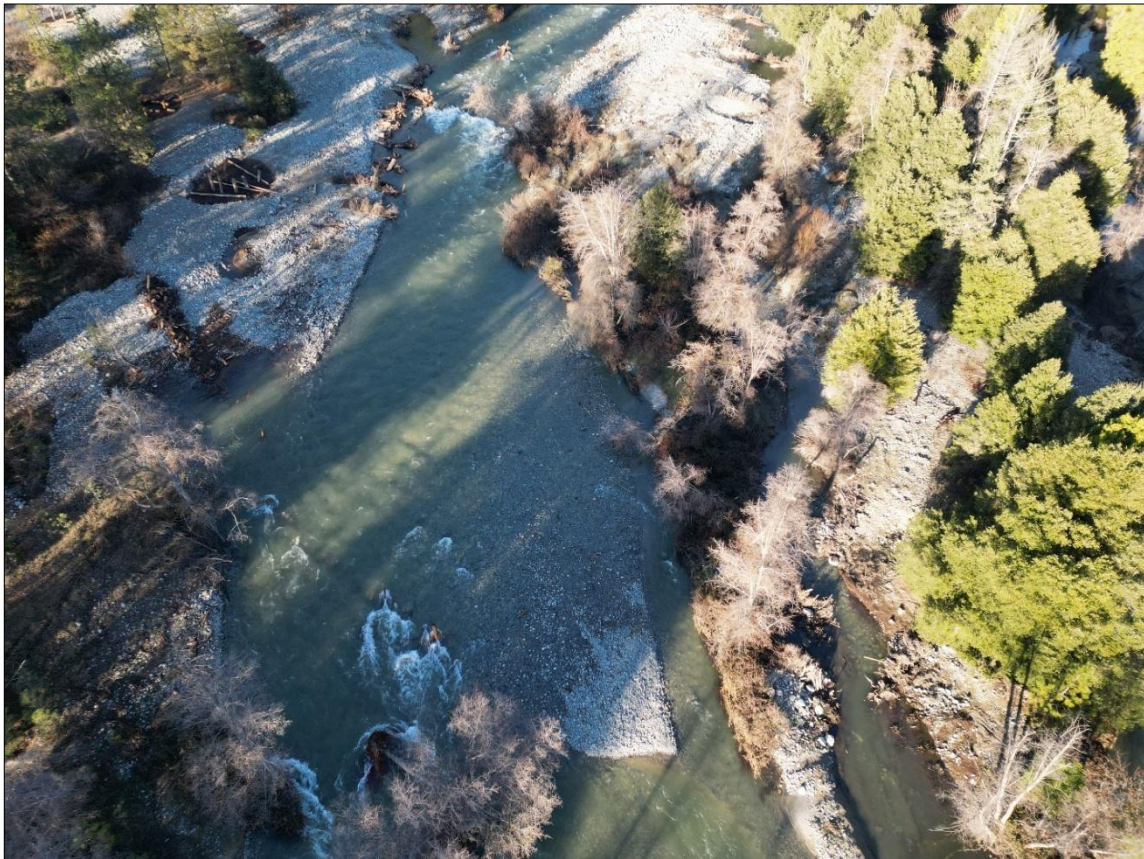
**Image 16 (above):** Aerial image of the Primary Side Channel post-phase two implementation. Photo taken as the hydrograph was descending, around 16,000 CFS (at the USGS gage) on December 30<sup>th</sup>, 2024.

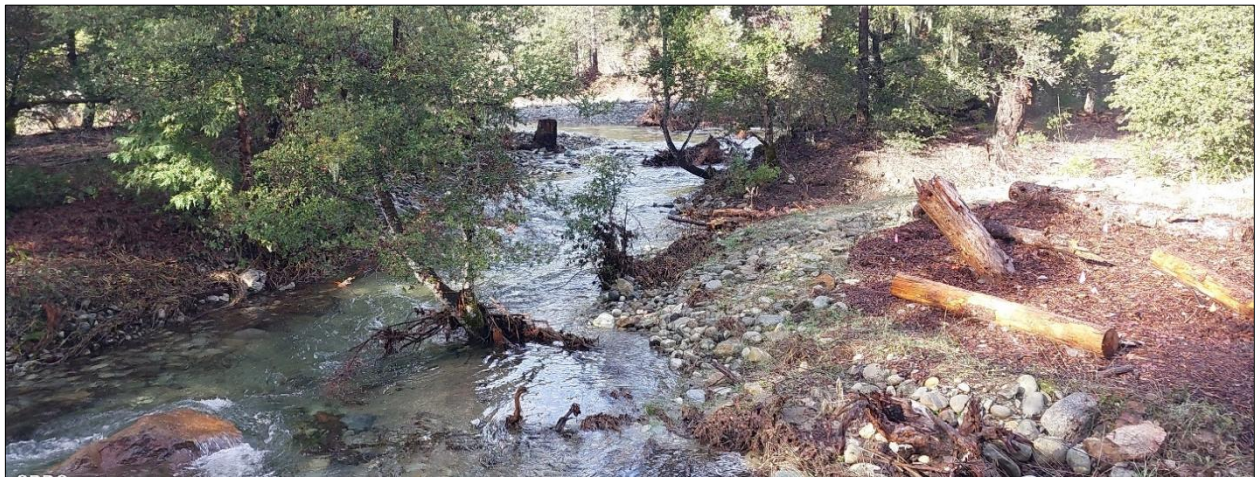
**Image 17 (above):** Improvements to connection between Far Side Channel and Primary Side Channel (upper Far Side Channel) were made in phase two of implementation. Photo from December 2024.

During the 2024 monitoring season, the Far Side Channel was connected to the Primary Side Channel at winter base flow as designed (see Image 17). The channel activated at lower flows than during winter 2023-2024 and connection improvements constructed during phase two of implementation increased flow from the primary channel significantly. Sedimentation in the Far Side Channel has been minimal, however there has been some good sorting behind log-structures in the lower channel reach before its confluence with the lower Primary Side Channels, also referred to as the Perennial Channel (Images 19 and 20).

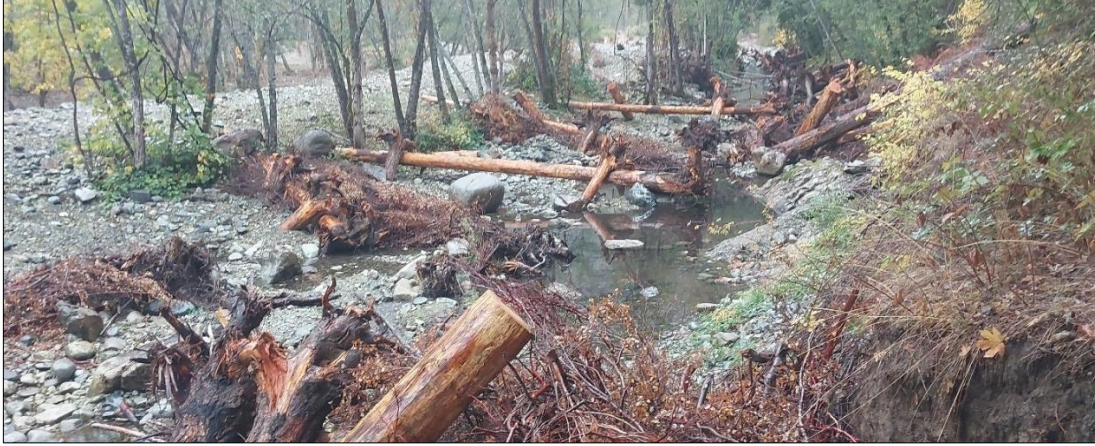
*Image 25 (above): Perennial Channel Log Structures (facing upstream). November 1<sup>st</sup> 2024*

functional change to the Perennial Channel during these periods. During these particular high flow events, water levels in the Perennial Channel exceeded the heights of log structures, however the structures remained intact with little to no observable log movement or structural change.

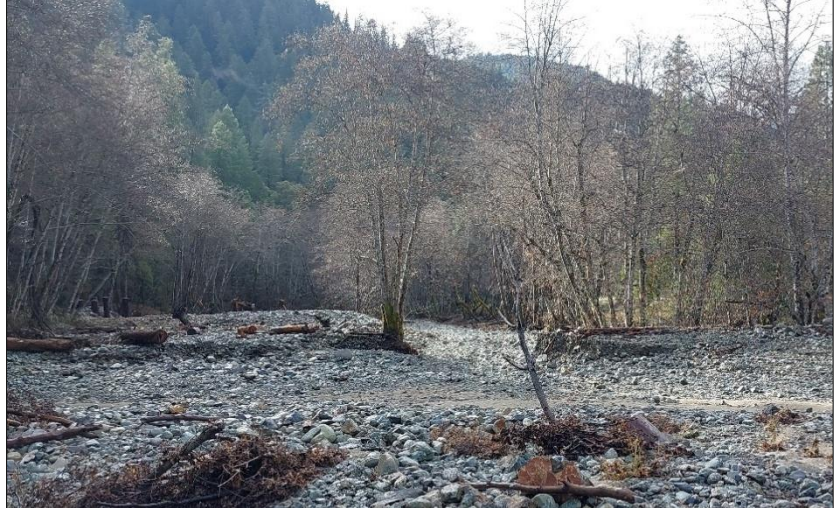
*Image 26 (left): The Secondary Channel inlet (dry) lies on stream right of the Lower Primary Side Channel (flowing). See the gap in the alders of the prior to berm construction in August 2024. Photo from April 2024.*

The Secondary Channel activated beginning on November 22<sup>nd</sup>, 2024 (see Lessons Learned). This channel was expected to activate in a 1.5-year event and that that particular high flow was a 1.7-year event. Storm flows overtopped the enhanced planting area just downstream of the confluence of the Far Side and Primary Channels. Over time this flow path cut a channel into the berm built in 2024 at the entrance to the channel, thereby increasing the amount of flow conveyed by the Secondary Channel (see Images 27, 52, 57, and 58). This berm was built to divert moderate flows into the Perennial Channel and create a passive backwater from the North Fork Salmon River into the Secondary Channel (Backwater 3). In Spring 2025 the Project Team will evaluate whether any modifications to the constructed berm are warranted.

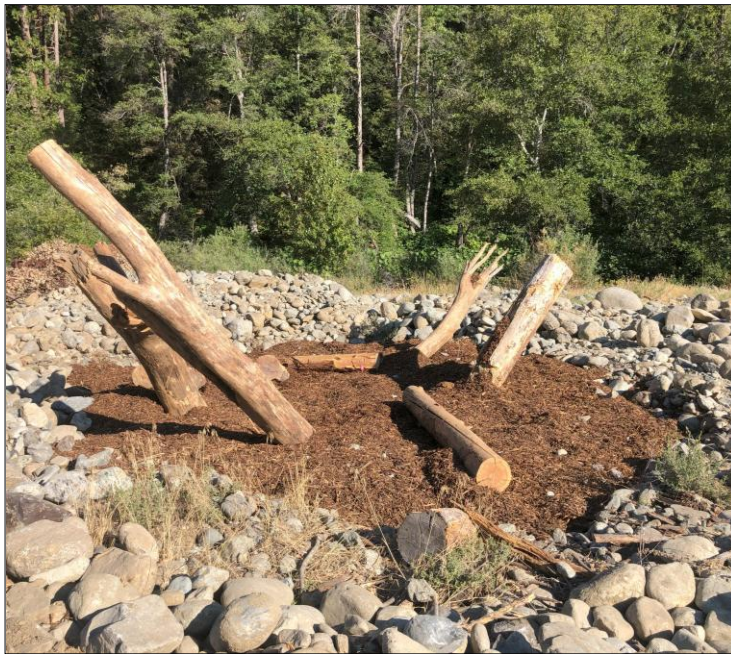
***Image 41 (left):*** A finalized small Enhanced Planting Area (EPA) built in 2024, which is roughly 20'x20' in dimension.

During construction seasons one and two, heavy equipment was used to create Enhanced Planting Areas (EPAs) and slot-EPAs, which were excavated to groundwater, augmented with vertical logs which function as wicks, backfilled with quality soil salvaged from the site as well as slash and chips, and covered in wood mulch (see Image 41). The slot-EPAs differ from other EPAs in that they were placed on the slopes of backwaters and alcoves, in a narrow oblong configuration with cover rootwads emerging from the ground surface (see Image 42). EPAs built in 2023 were partially planted and partially mulched in Fall 2023 (Objectives 5 & 7). On July 9<sup>th</sup>, before the second season of construction and earth moving, SRRC plants program staff visited the site to monitor the survival of 2023 plantings and to mark all plantings from 2023, regardless of survival status. This was done to help the contractors place mulch in the EPAs without burying the individuals planted in these areas in fall 2023.

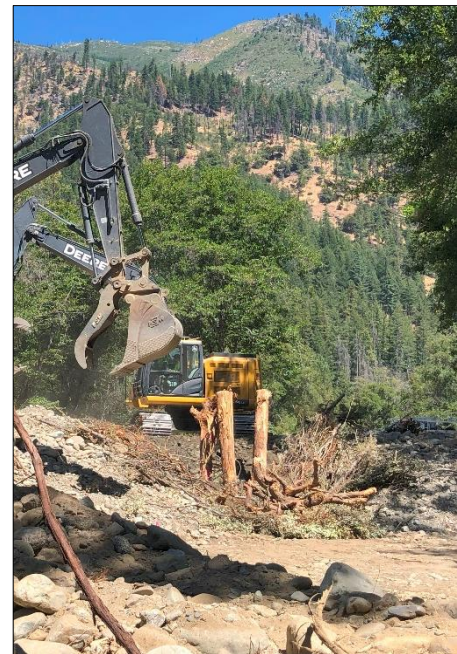
***Image 42 (right):*** A Slot-EPA under construction. These features were constructed with logs, slash, cuttings, and fill material, and were then mulched.

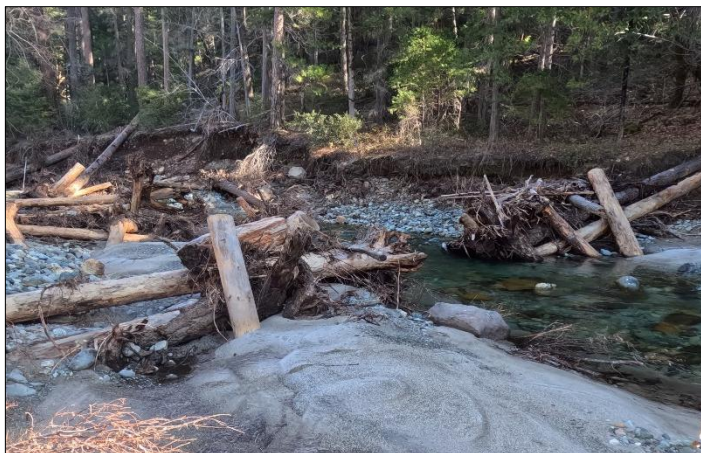
***Image 49:** During high flows log structures in the Perennial Channel scoured pools, sorted and aggraded sediments. January 2025.*

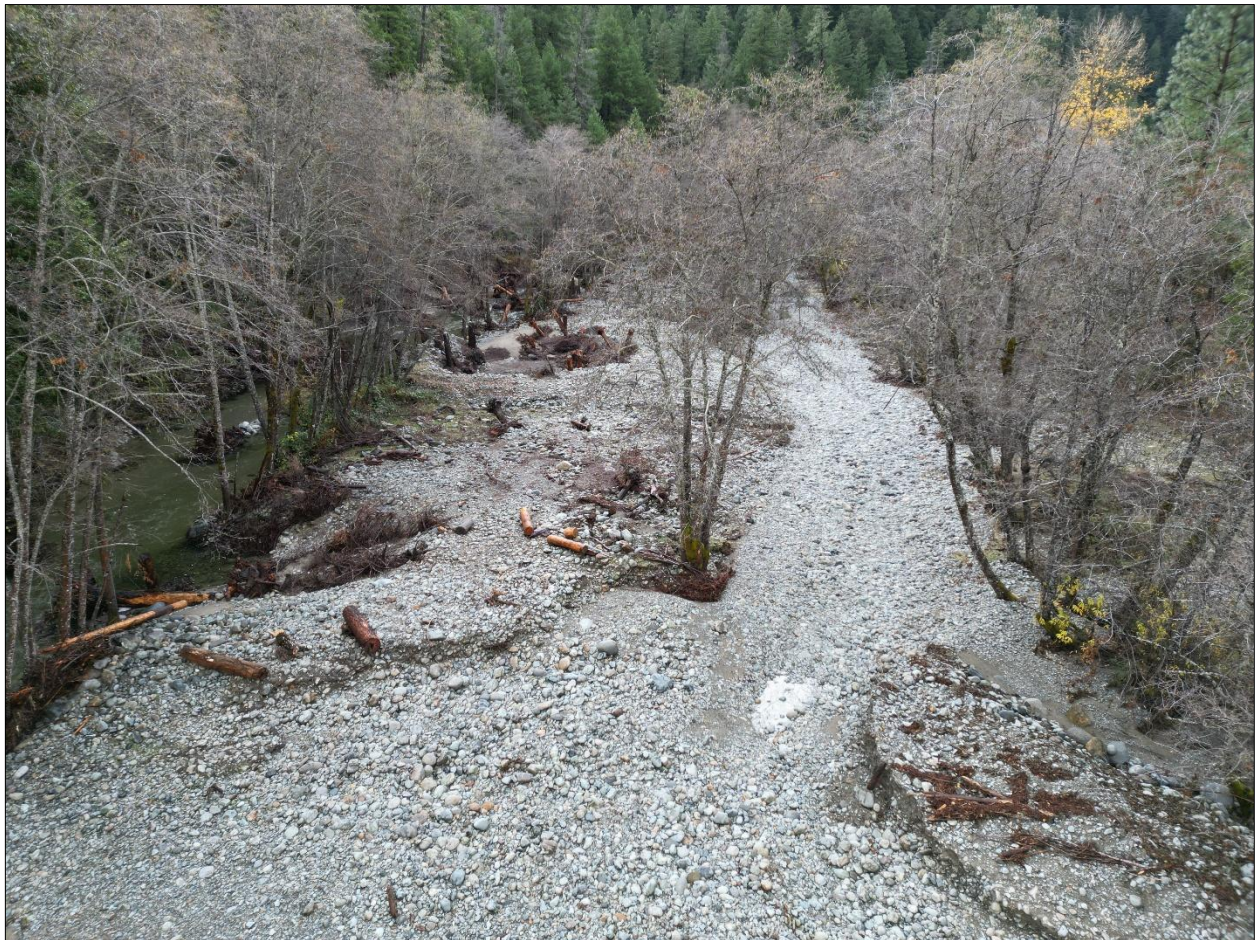
**Image 52 (above):** The Secondary Side Channel inlet on stream right between high flows. Note the scour through the constructed berm. November 26, 2024.

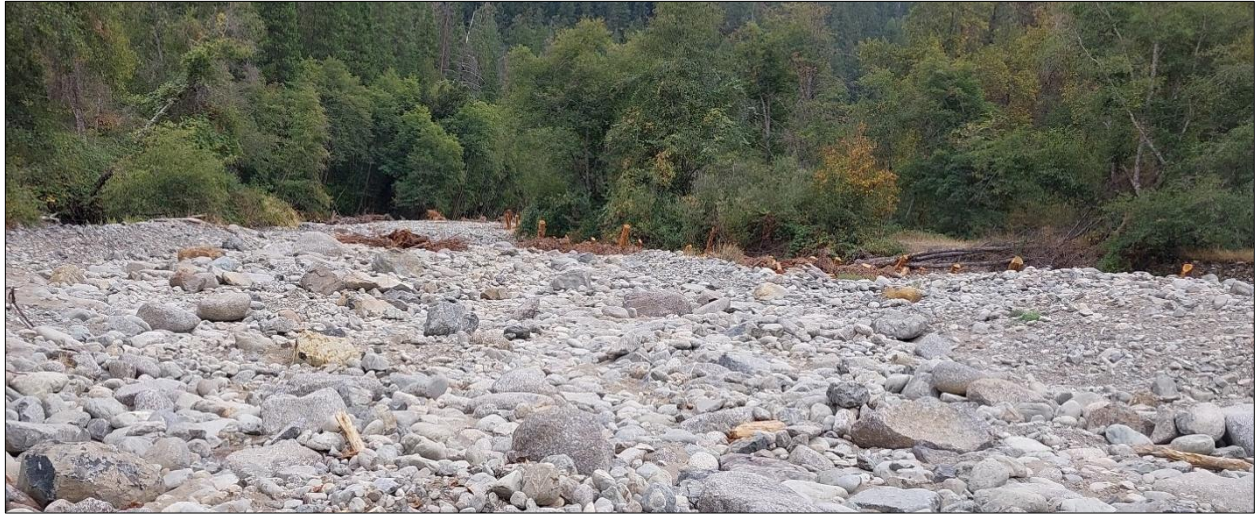
**Image 53 (above):** The Primary Side Channel log revetment completed in phase two of construction (seen center right). October 2024.

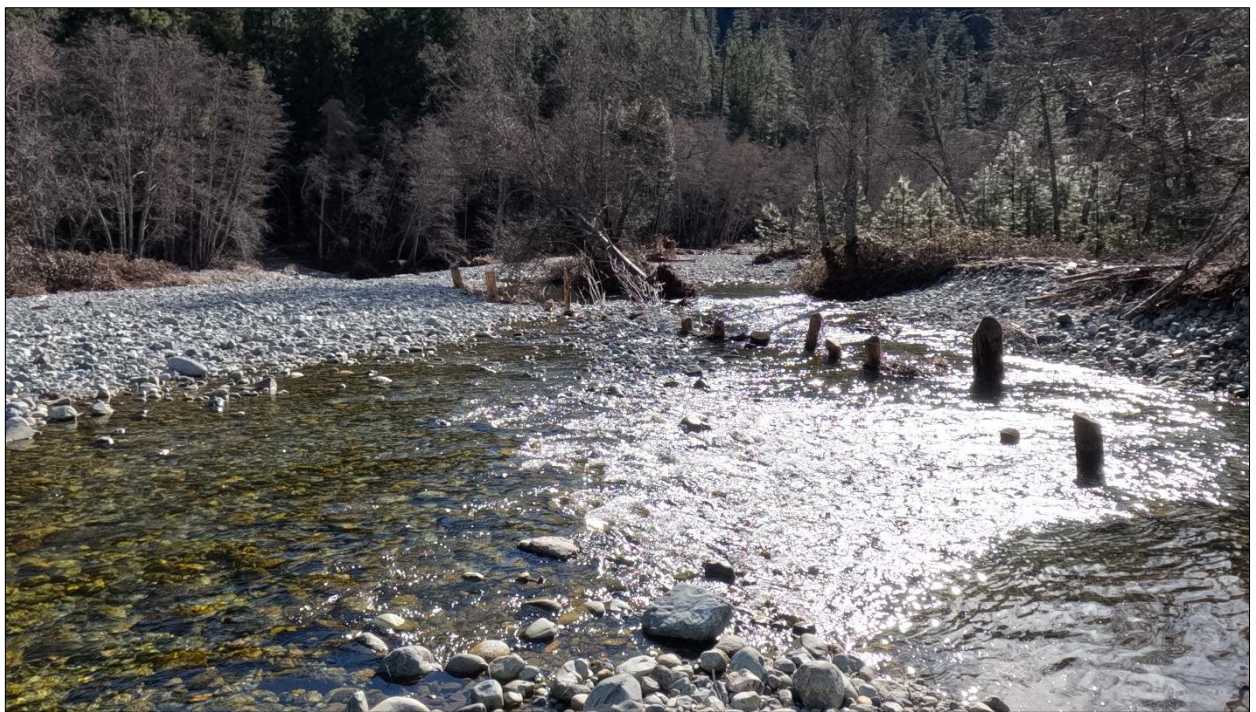
**Image 54 (above):** The Primary Side Channel from the mid-bar perspective, facing downstream. This channel cut a new flow path through the bank revetment mid-bar in the 2024 winter high flows (seen center right). December 2024.

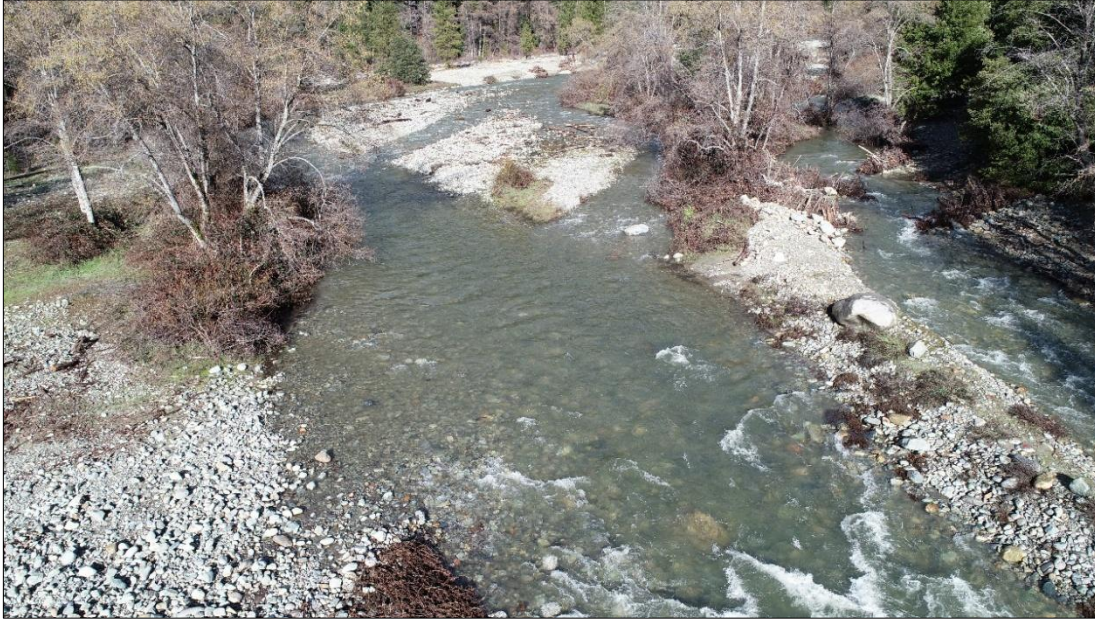
**Image 55 (above):** The Primary Side Channel from the mid-Bar perspective, facing upstream, in January 2024. Note the clump of alders on the left.

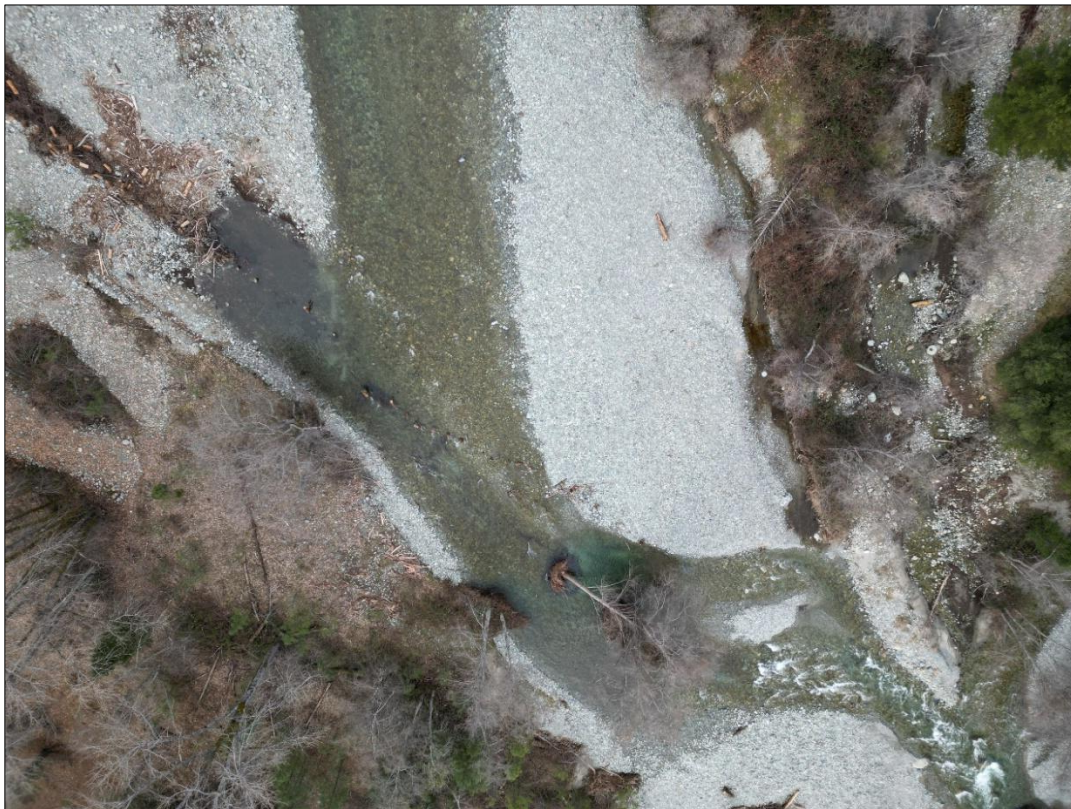
**Image 56 (above):** The Primary Channel from the mid-Bar perspective, from above, in February 2025. Note the clump of alders seen on left in the photo above is now in the middle of the Primary Side Channel.

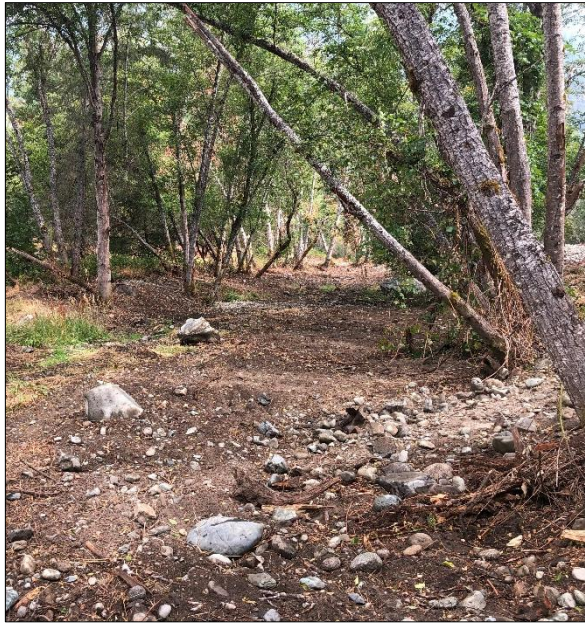
**Image 57 (left):** Secondary Side Channel post-phase two implementation. August 2024. Note the bed material is characterized by fine sediment.
