North Fork Salmon River Red Bank Off-Channel Fisheries and Riparian Habitat Enhancement Project

Final Basis of Design Report

May 2017

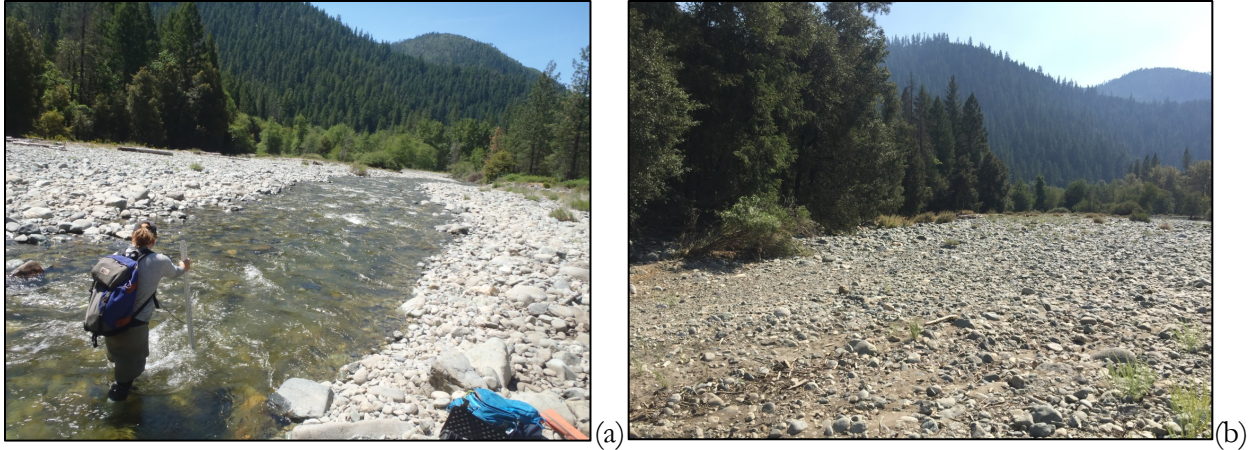
Figure 3-7. The Upper Side Channel looking downstream (a) on 5-13-16 at an approximate river discharge of 630 cfs (Photo by SRRC) and (b) same location on 9-8-16 when the side channel is dry.

Upper Side Channel: The upper 860 feet of the Primary Side Channel originates from a glide in the river at the head of Red Bank Bar. Figure 3-7 shows the upper portion of the side channel both flowing and dry.

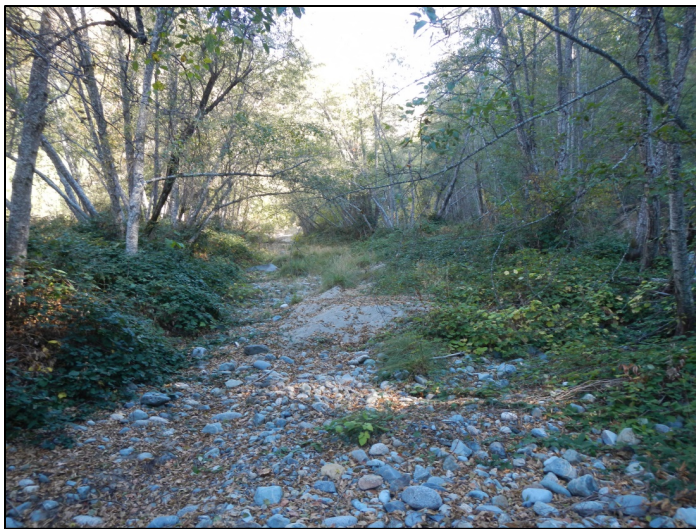
Figure 3-11. Photograph of Secondary Side Channel. Large sculpted boulders are present in the channel.

Like the Primary Side Channel, the Secondary Side Channel is a plane-bedded channel with few forcing features to create channel bed complexity and flow diversity. Boulders sculpted by flowing water are present in the Secondary Channel (Figure 3-11), indicating that it conveyed sufficient flows for a duration of time to sculpt the boulders.

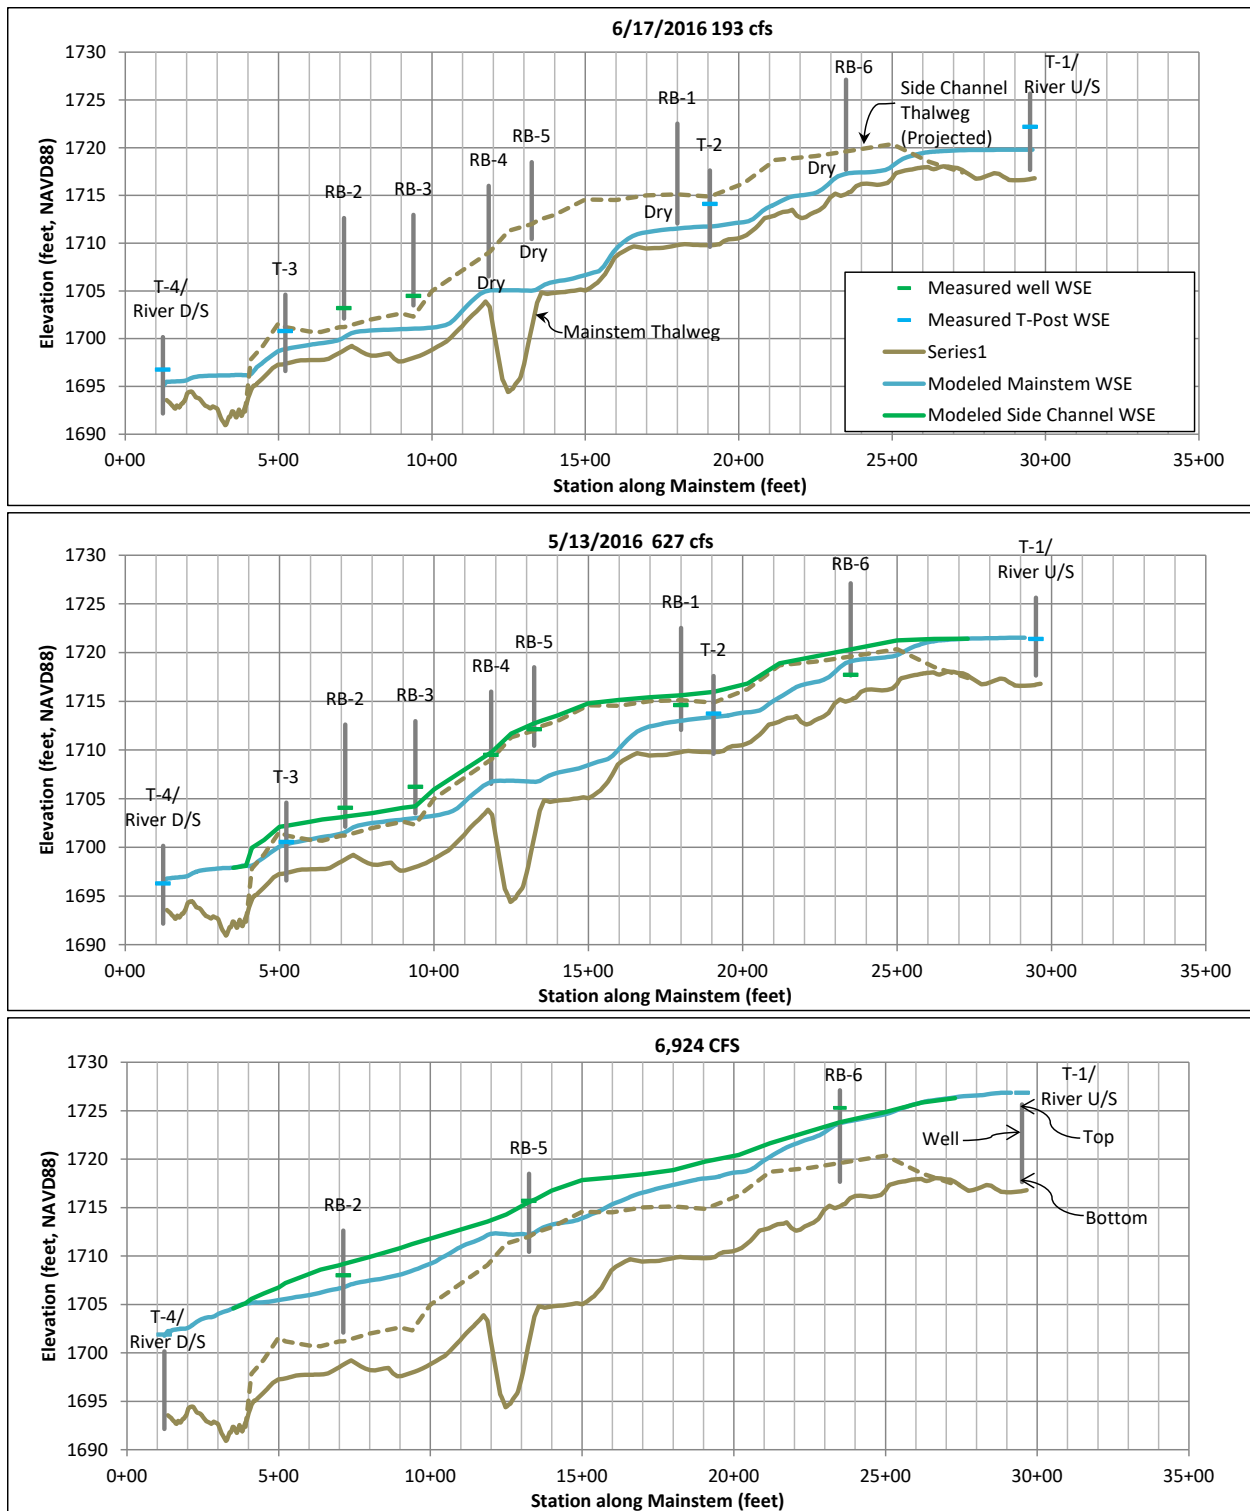
Figure 4-2. Measured groundwater and surface water elevations at wells and T-posts along the NF Salmon River and main side channel on Red Bank Bar. The side channel profiles are projected onto the river stationing. “Dry” indicates well was dry at time of direct measurement.

Figure 4-2 presents the results of the ground and surface-water monitoring for three of the monitoring events, reflecting the conditions during monitored river flows of 193 cfs (55% daily exceedance flow), 627 cfs (16% daily exceedance flow), and 6,924 cfs (approximately 3-year flow event). Water surface profiles derived from the calibrated hydraulic modeling (See Chapter 5) are also shown on the profiles. The profiles in Figure 4-2 show the thalweg and river WSE, with the side channel thalweg and WSE projected perpendicularly across the valley onto the river stationing. For the 6,924 cfs event no direct measurements were made at T-posts or wells and only data derived from the stage-flow rating curves for each well are shown. Similar plots for the other monitoring events and flows are presented in Appendix G.

As shown in Figure 4-2 and Appendix G, model-predicted flows were generally within 0.5 feet of measured water levels, with exceptions as discussed below. The similarity between measured and model-predicted flow provided confidence in the results for modeling of flows during which direct measurements were not taken.

Inspection of the plots in Figure 4-2 and Appendix G suggest that the hydraulic gradient from the river and Primary Side Channel upstream of RB-2 and RB-3 and the narrowing of the overall valley width from upstream to downstream may be driving hyporheic flow and maintaining the observed perennial flow in the lower part of the side channel adjacent RB-2 and RB-3. The perennial flow is also supported by springs emerging along the eastern bank of the side channel, close to the adjacent hillslope.

During flows higher than about 1,000 cfs, water levels in RB-2 (RB-3 did not have a continuous data logger) are lower than the water surface in the adjacent side channel but higher than the river level. This may suggest that at high flows the Lower Side Channel is a "losing reach." Alternatively, the well could be less responsive to rapid changes in surface flows than at other monitoring wells due to localized subsurface conditions that delay the response of the well.

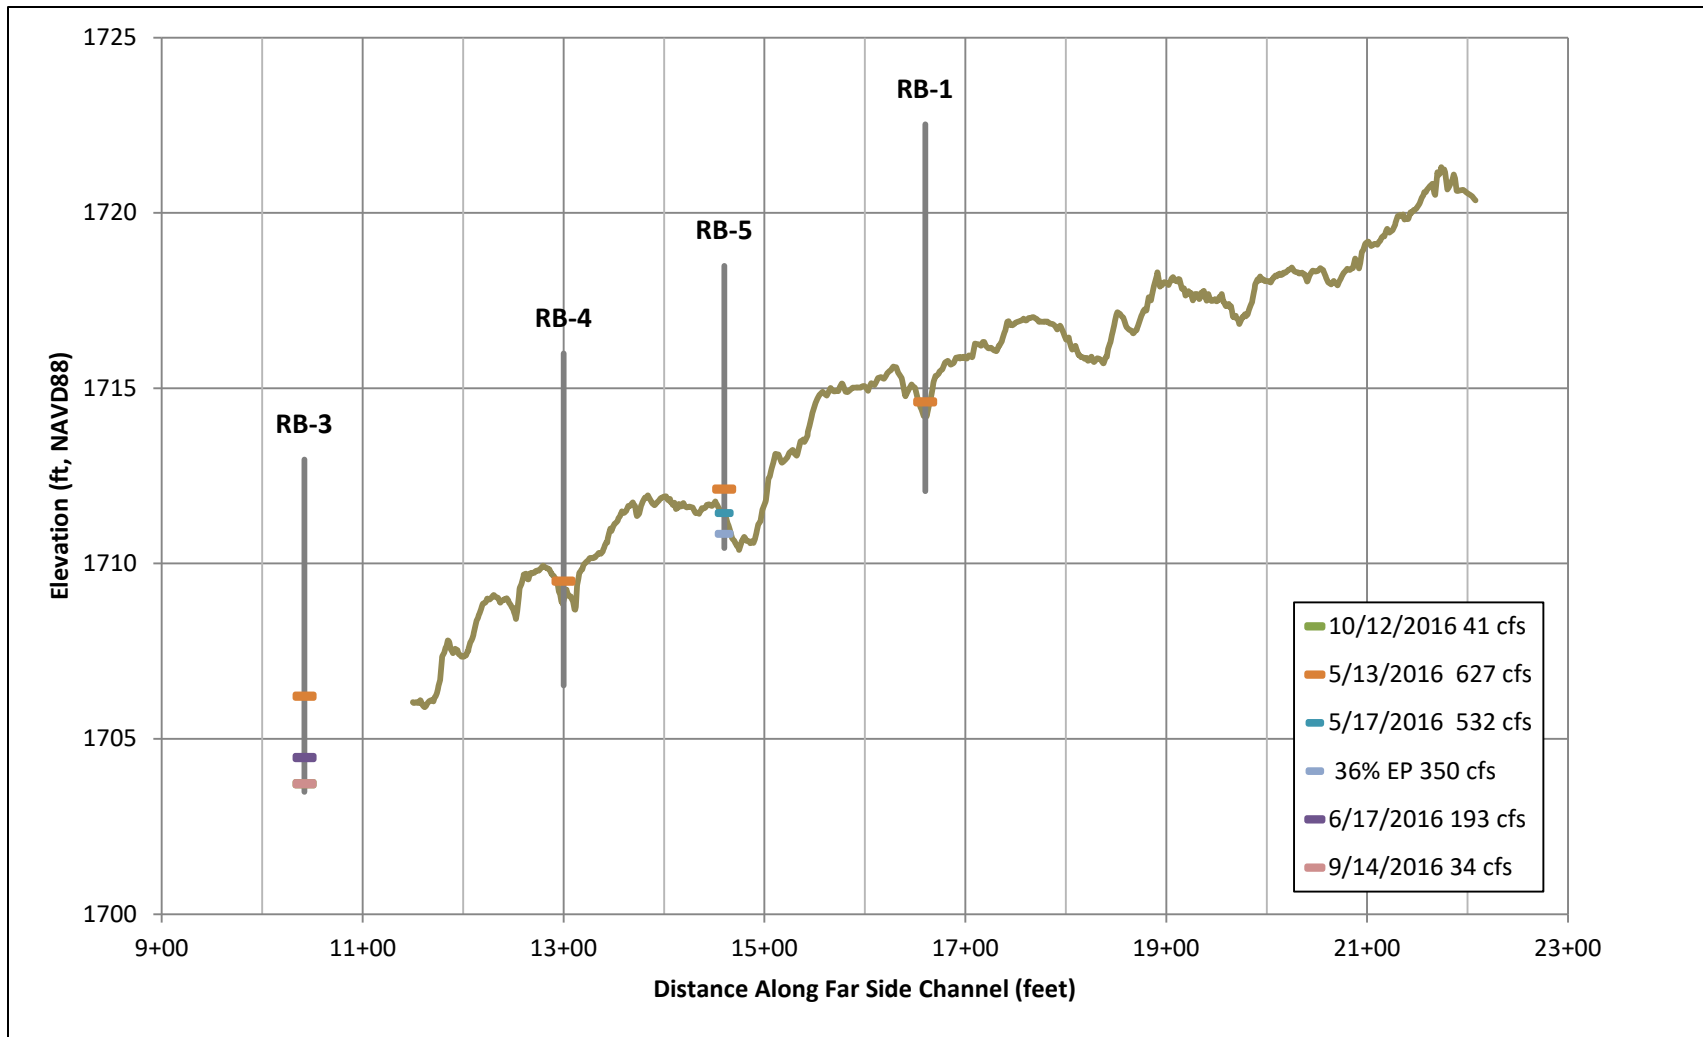
Figure 4-3. Thalweg profile of the Far Side Channel showing groundwater elevations for various flows in the river. Missing data indicates that well was dry. Data was not collected at RB-1 and RB-4 on 5/17/16. Data was not collected at RB-1 RB-3 and RB-4 on during the 350 cfs flow event.

Figure 4-3 presents a profile of the Far Side Channel with the limited amount of groundwater elevation data collected. Note that some observations are missing, rather than the wells being dry.

Field observations indicated the Far Side Channel receives subsurface flows from the Primary Side Channel, causing it to contain flow for most of the winter and spring months, though these pools dried out in mid-May, 2016, when river flows were about 550 cfs. The Far Side Channel also receives surface flow from the river when flows in the river exceed 650 cfs (16% exceedance flow). Frequent scouring flows and the depth to groundwater in the upper portion of the Far Side Channel

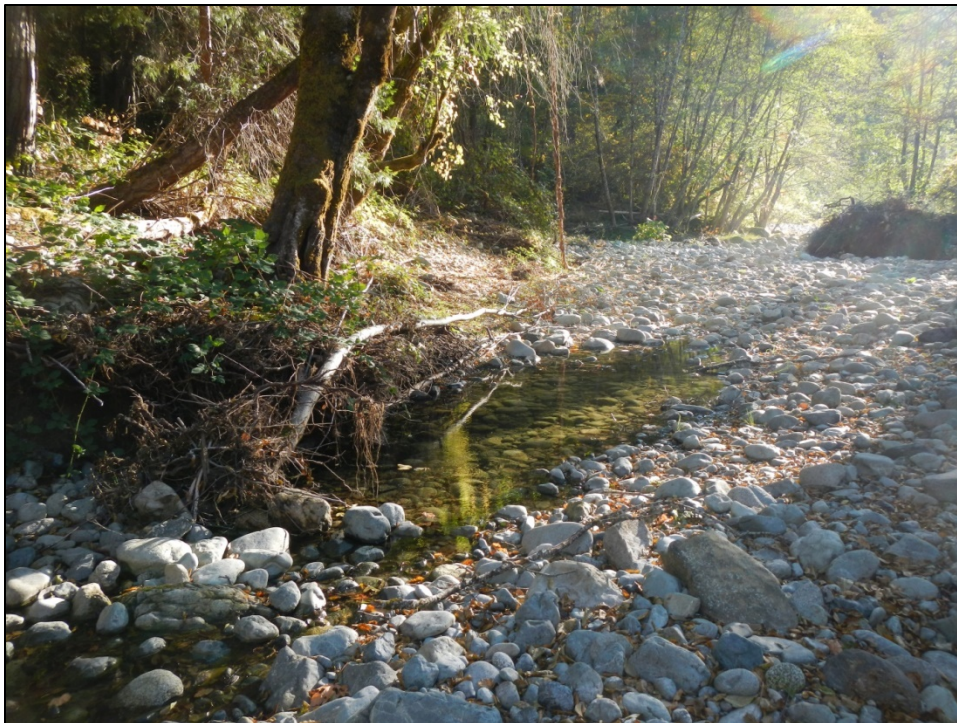
Figure 6-7. Scour hole that developed adjacent to exposed tree roots in the Lower Side Channel. Water filling the hole is groundwater and salmonids were present in October, 2016.

Trees with root fans partially obstructing flow, or that have fallen and laying on the streambank often cause localized constrictions and accelerations in flow velocities that result in the development of a scour pool around the tree roots. A photograph of a tree adjacent to the Lower Side Channel with scour around its roots is shown in Figure 6-7. An approximately 1.5 to 2-foot deep scour pool had formed around the roots of this tree and was filled with groundwater, providing thermal refugia with complex cover. Salmonids were present in this pool in October, 2015.

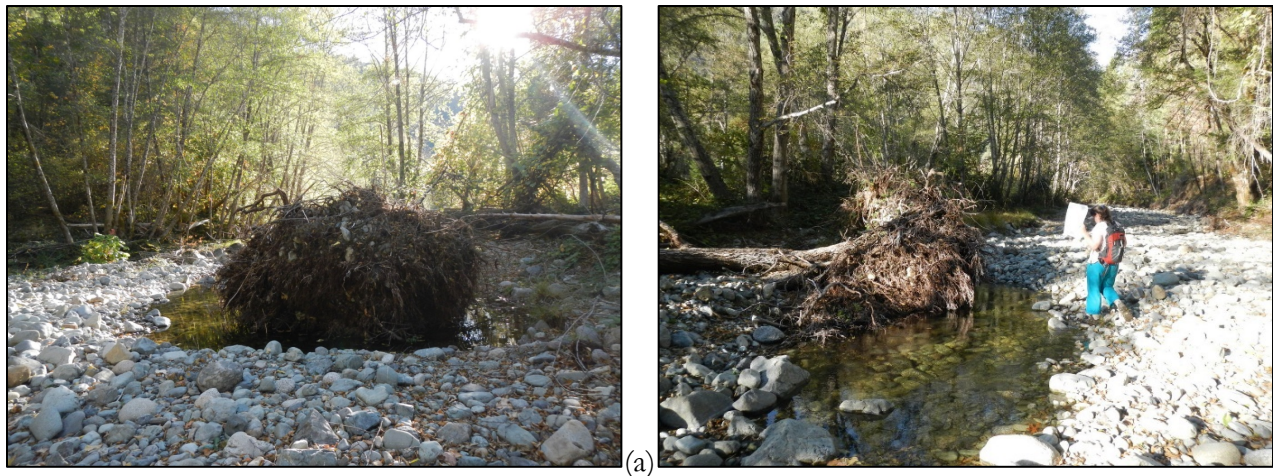
Figure 6-11. Photographs of an Apex Jam in Lower Side Channel at Red Bank Bar (a) looking downstream and (b) looking across the channel. Note the crescent-shaped groundwater fed pool around the root fan.

A photograph of a downed tree forming an Apex Jam in the Lower Side Channel at Red Bank Bar is shown in Figure 6-11. At Red Bank Bar, an approximately 3-foot deep scour pool had formed around the root fan and was filled with groundwater, providing optimal thermal refugia with complex cover. Because the downed tree forming the Apex Jam at Red Bank Bar was not anchored in place, it has floated away since it was initially observed. However, with suitable anchoring, Apex Jams can be used to create persistent high-flow refugia and pools that provide thermal refugia.

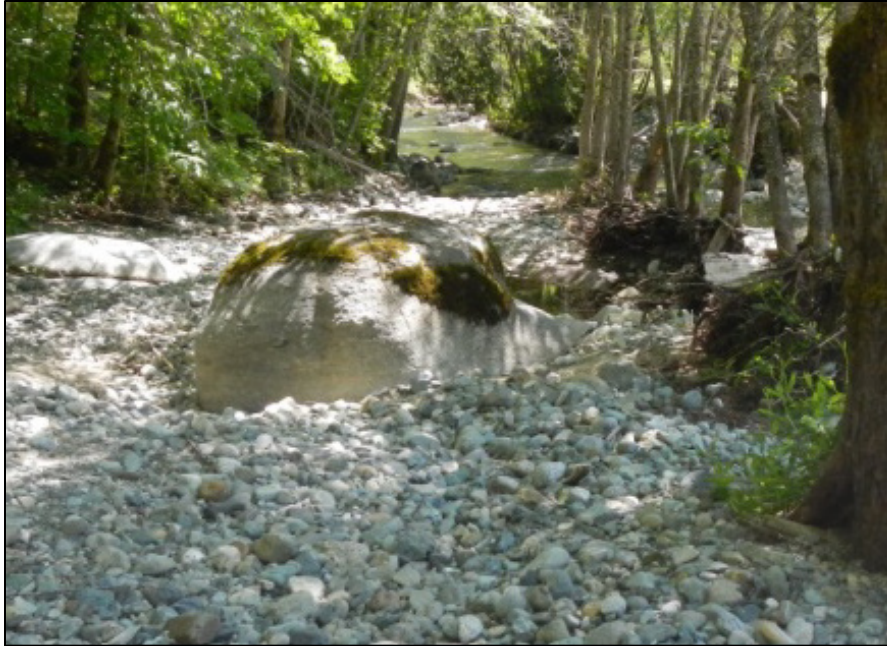
Figure 6-14. Large boulder in one of the Red Bank Bar side channels (looking downstream). Note the crescent shaped scour pool around the upstream side of the boulder and scour pool on the downstream side of the boulder.

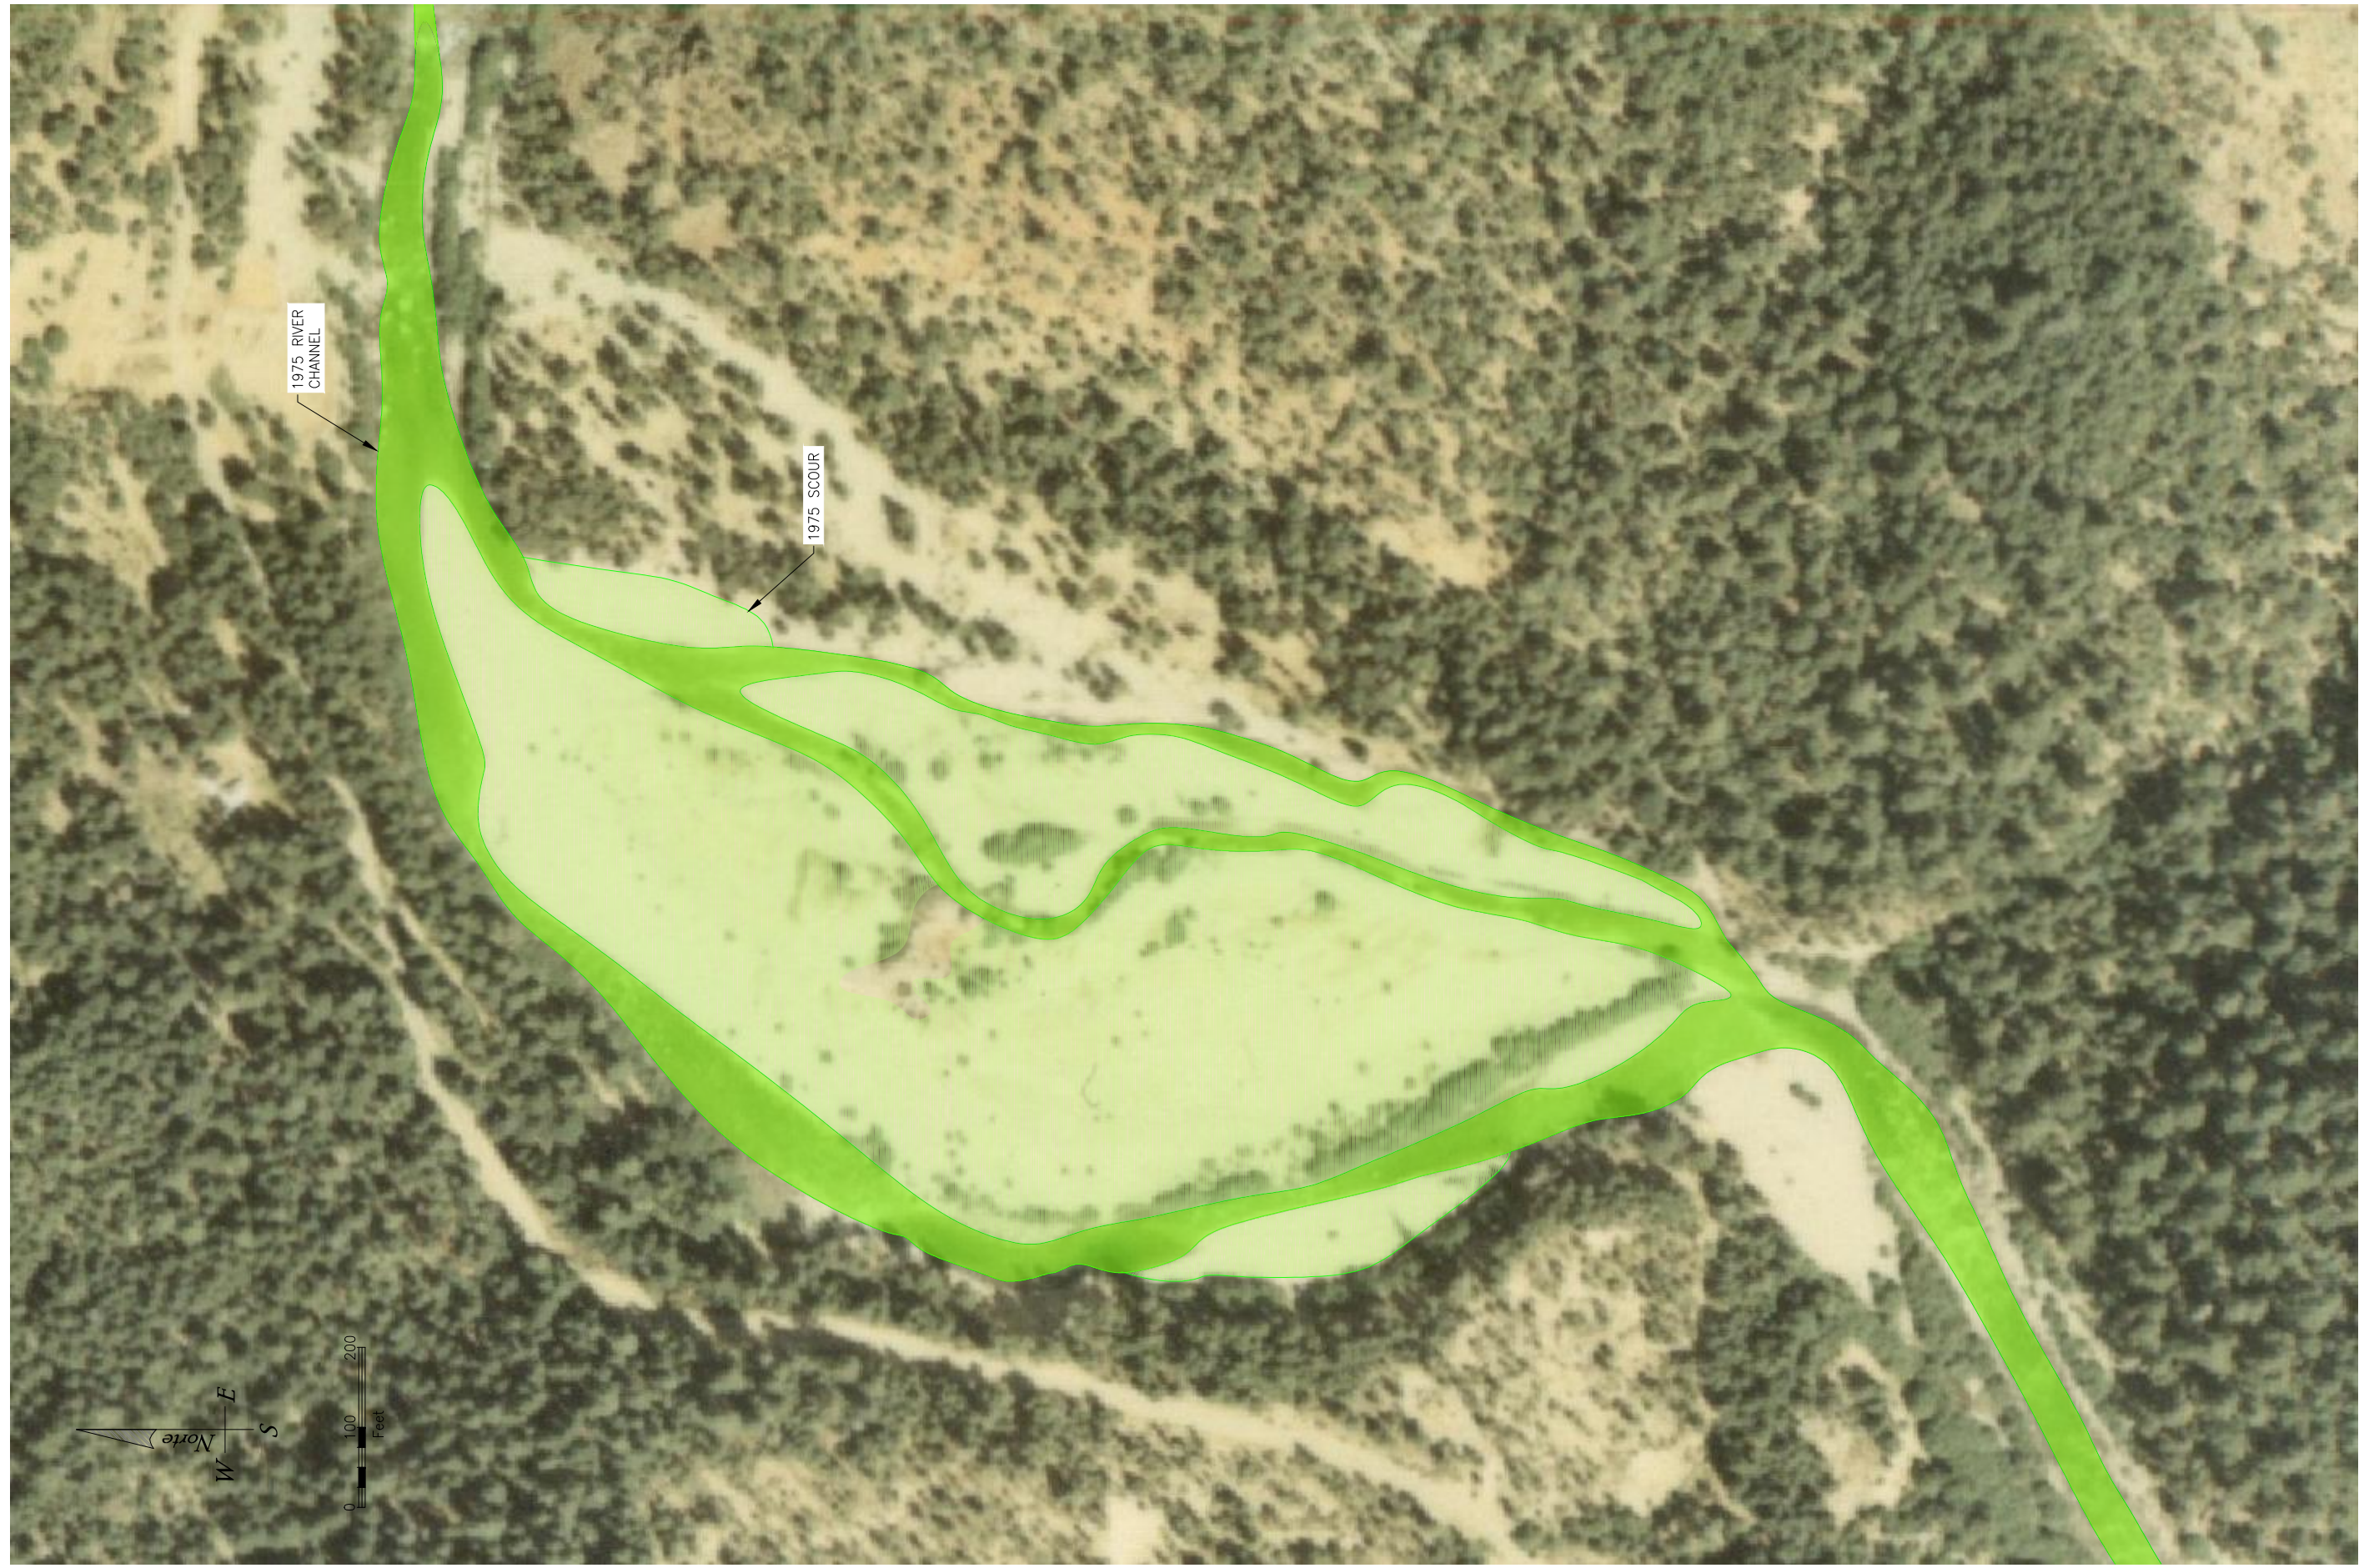
DATE	JAN. 2017
SUBMITTAL	
DESIGN	RS
DRAWN	NN
FIGURE	3

Red Bank 1965

Observed Changes in 1965 Air Photo
