Title: South Fork Salmon River Tributary Salmonid Enhancement Monitoring Project

January 2020

One Sentence Summary: Monitoring of instream large wood structure placement within two anadromous tributaries in California's South Fork Salmon River watershed demonstrates increased and enhanced fish habitat through gravel substrate retention, accelerated recruitment of wood cover and increased variable hydraulic refugia.

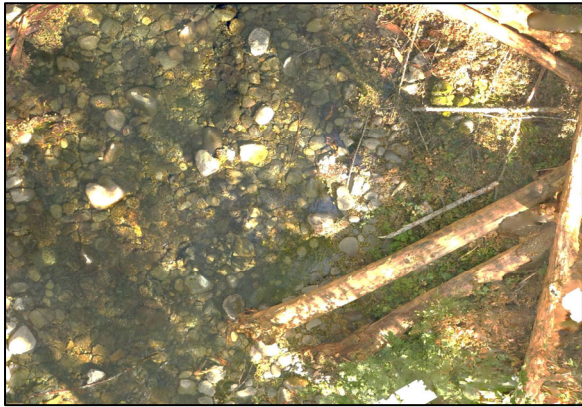
Figure 2. An example of the multiple steps taken to make the final post-implementation analysis map used to quantify site changes and evaluate effectiveness.

Step 1. Post-construction site scale orthomosaics are developed prior to high-flow engagement of the site.

Step 3. Post-high flow orthomosaics are laminated with Mylar to provide a base for facies mapping in the field.

Step 2. Post-high flow orthomosaics are developed and co-registered to post-construction orthomosaics to support change analysis and effectiveness monitoring.

Step 4. Interpreted field map is brought into GIS software for digitizing of substrate facies, LWD and racked wood features.

UAV-based orthoimagery was used to develop post-implementation (as-built) site mosaics in the fall of 2017. The process was then repeated during low-water conditions in the fall of 2018 and 2019.

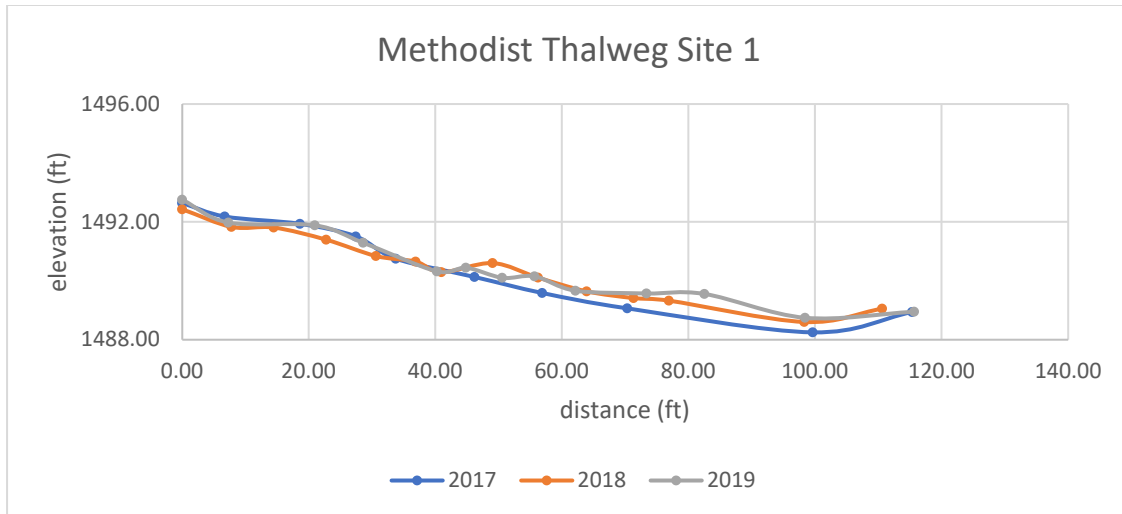
Figure 3. Channel thalweg survey plot, Site # 1 Methodist Creek.

Thalweg profiles and channel cross-sections were physically surveyed for each large wood site location reach prior to construction and for two additional years following the winter flow seasons (Figure 3).

Physical channel metrics obtained from the surveys include: channel gradient, bankfull width and depth, sinuosity, pool frequency and residual pool depth. Results from the topographic channel surveys are shown in Tables 1a and 1b, below. Additional thalweg profiles and channel cross-sections are included in Appendix A.

Channel gradients remained relatively stable at treated reach scales. However, localized scour and deposition can be noted in the physical surveys and data metrics. Overall reach scale channel gradients ranged from 0.0-5.2% in Knownothing and Methodist Creeks, but individual sites varied only slightly over the monitoring period (Tables 1a and 1b). Sites in both Knownothing and Methodist Creeks displayed either slightly increased, slightly decreased or neutral channel gradient changes, with no overall consistent pattern (Tables 1a and 1b; Appendix A). This may be a result of the coarse boulder and bedrock dominated substrates in both Knownothing and Methodist Creeks, making for a relatively “hardened” and immobile stream bed, and the relatively low to modest stream flow regimes that occurred over the monitoring period.

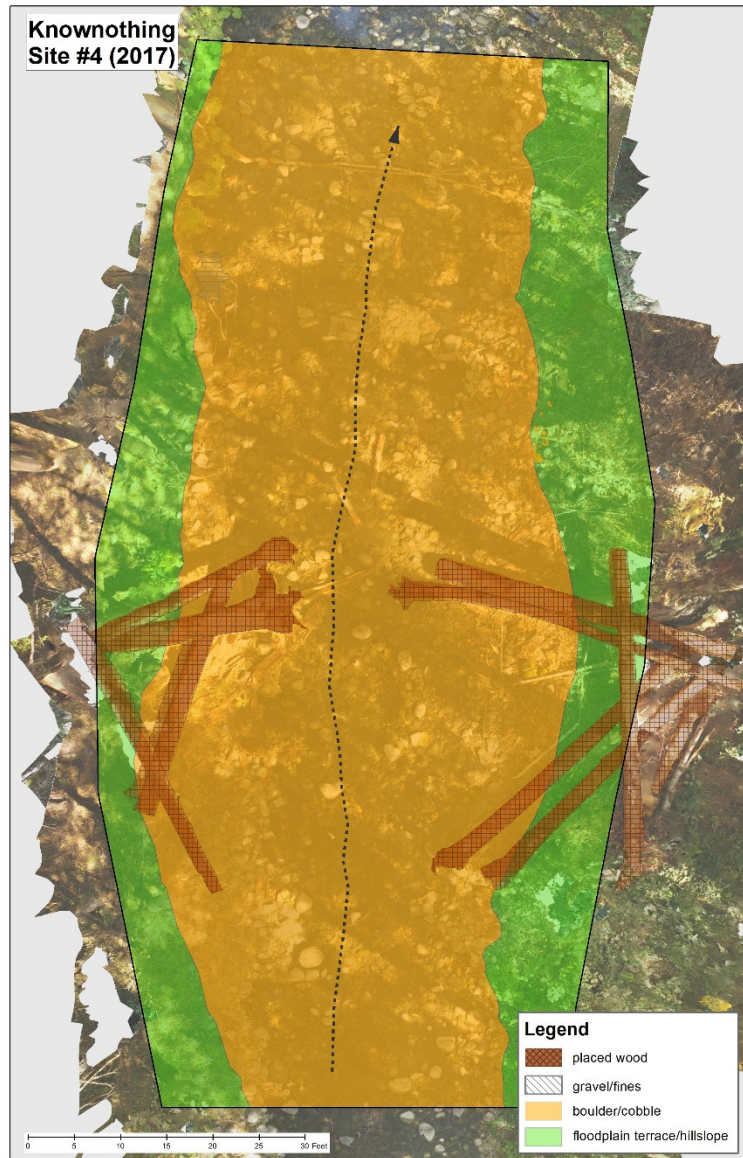
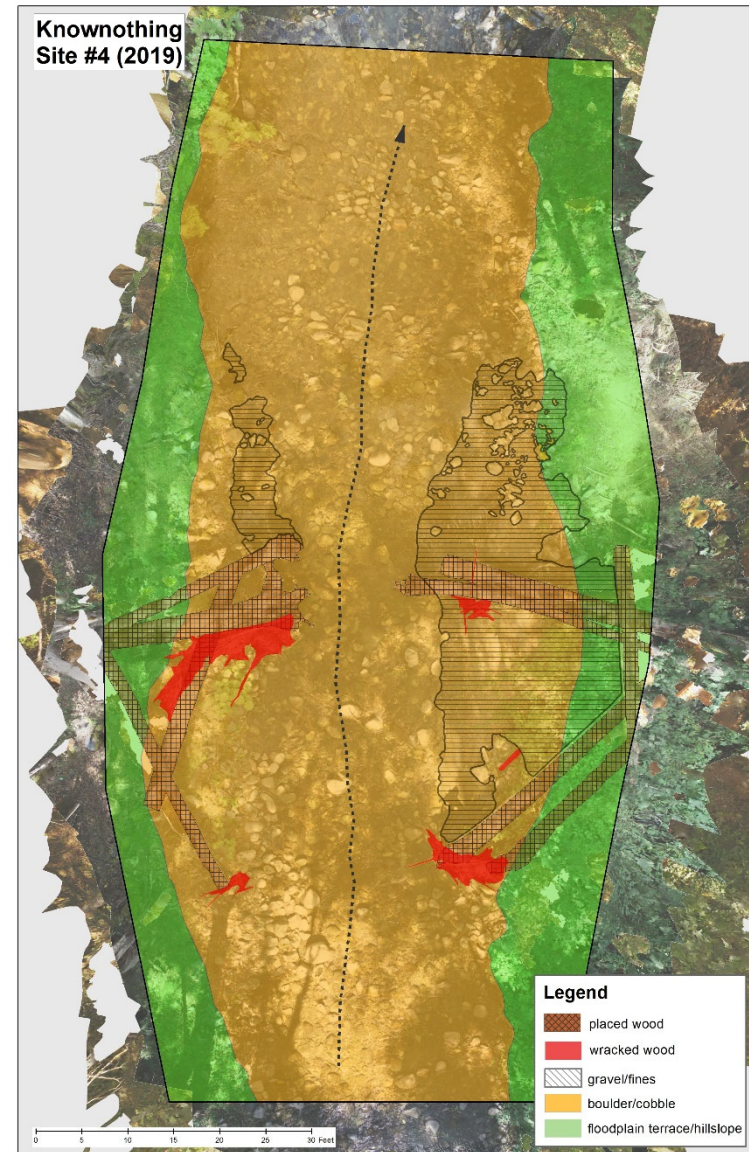
Figure 4a. Orthomosaic model for Site #4 in Knownothing Creek.

Due to the lack of significant high-flow discharge events and minimal response of the large wood features to winter stream flows in 2017/2018, only the feature-scale aerial imagery collected in Fall of 2019 was used to evaluate post-construction effectiveness metrics such as cover, raked wood and substrate area.

Knownothing Site #4 is an interesting anomaly in that this large wood structure deposited the highest area of gravels and fines and created a scour pool between the opposing large wood structures, but the data shows a particle size increase from year 2018 to 2019. This anomaly could be explained in that the cross-section location was far enough downstream that the retention of gravels and fines along the large wood “starved” the downstream channel bed of smaller particle sizes giving way to larger particle size detection in the pebble counts.

UAV orthoimagery analysis demonstrated that constructed large wood structures remained relatively stable over the 3-year monitoring period in both Knownothing and Methodist Creeks (Tables 2a and 2b; Appendix B). Eighteen features (excluding M3) showed a measurable increase in woody cover, obtained through the retention of racked wood. This is a positive result considering one of the primary goals of the project was to create key log jams where additional wood could rack and thereby increase habitat cover and localized channel changes over time.
