**Basis of Design Report for the
Restoration of Hotelling Gulch
Cecilville, Siskiyou County, California**

October 2018

Michael Love & Associates

Basis of Design Report for the Restoration of Hotelling Gulch

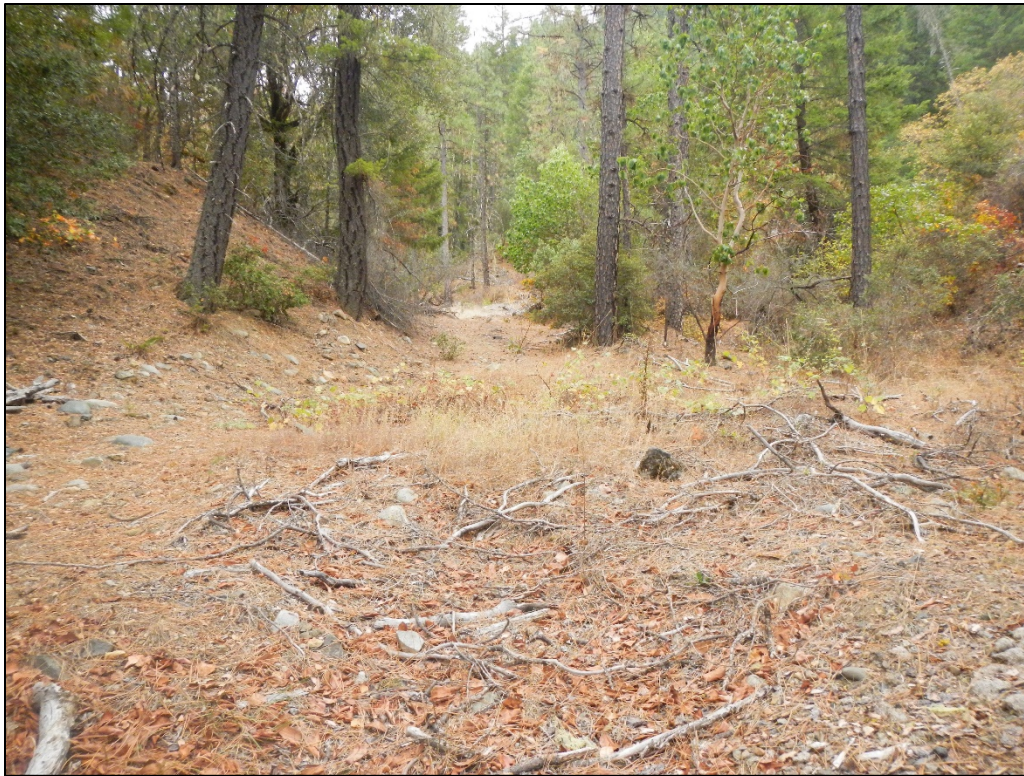
Figure 2. Historical stream valley of Hotelling Gulch into which the channel will be realigned.

facilitate fish access into Hotelling Gulch from the river, and provide seasonal and potentially perennial fish habitat. Figure 2 shows a photograph of the historical stream valley into which Hotelling Gulch will be realigned.

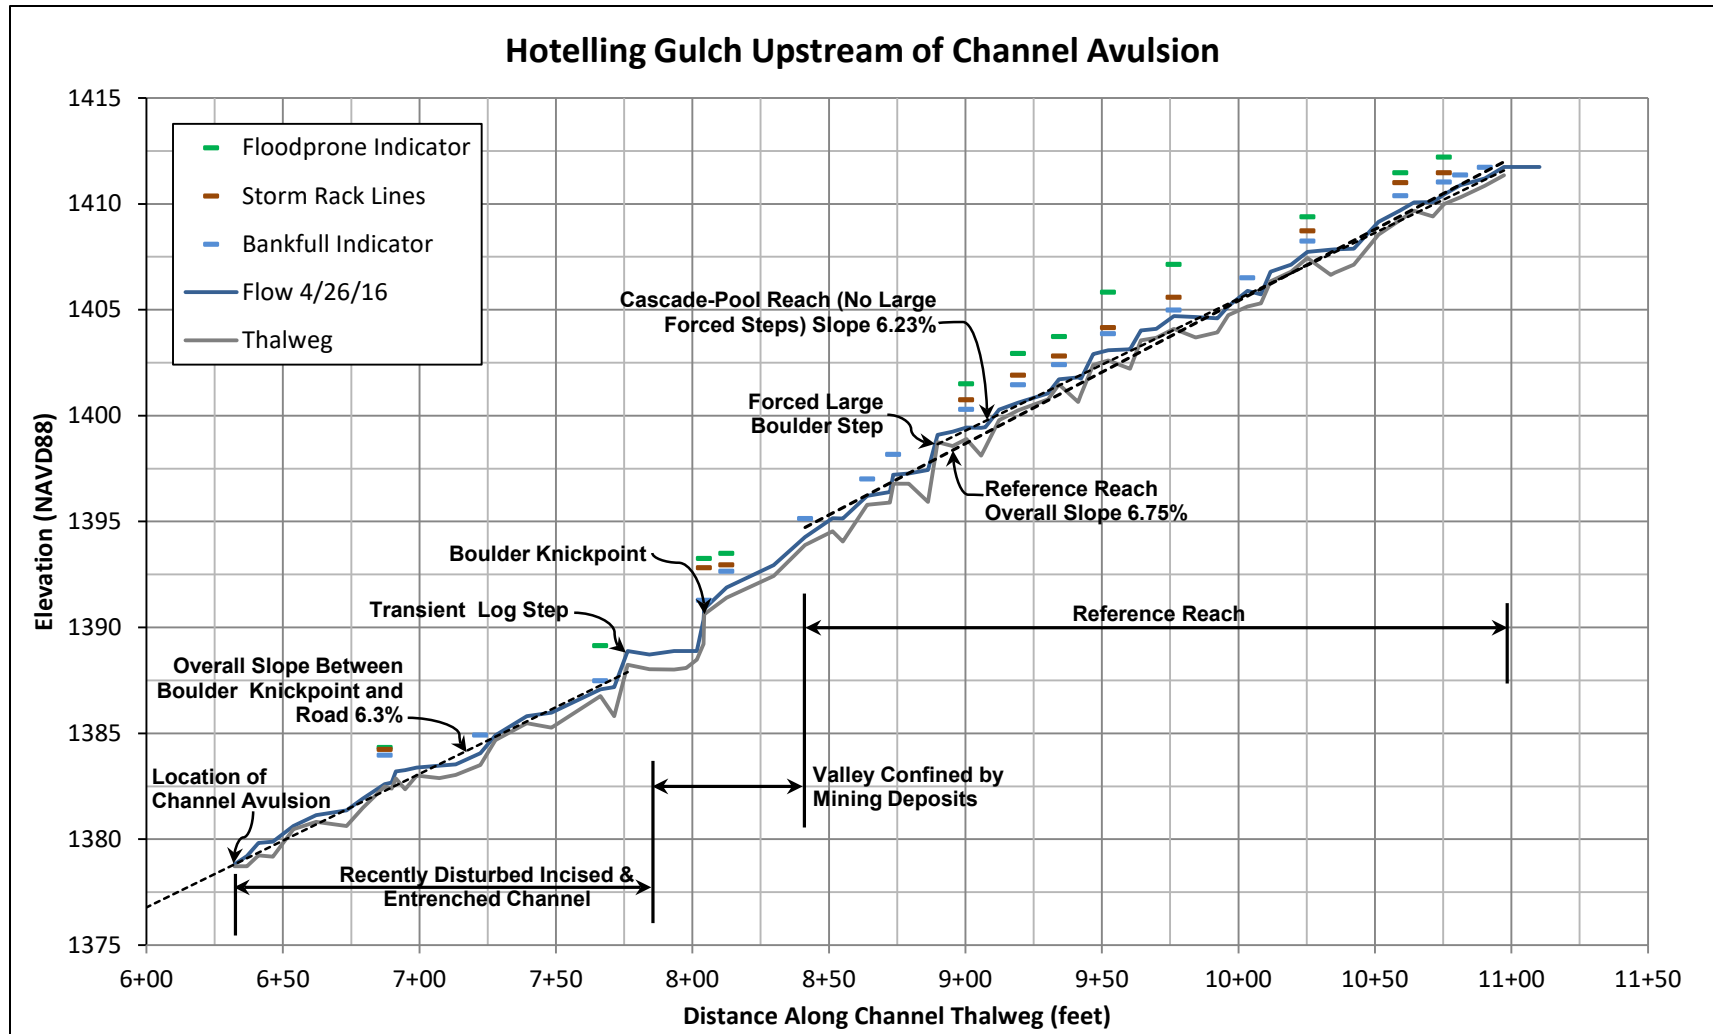
Figure 4. Channel profile of Hotelling Gulch upstream of channel avulsion.

Hotelling Gulch upstream of the channel avulsion is an approximate 10-foot wide channel with a profile slope between 6 and 7%, as shown in Figure 4. The step near station 8+05 appears to be a knickpoint, creating an approximate 2.5-foot offset between the upstream and downstream channel profile. A lobe of mining deposits along the west side of the channel confines the stream valley near this location, visible in Figure 3. This confinement appears to have played a role in delivering the large boulders that form the stable step that has arrested the knickpoint.

As shown in Figure 4, the channel reaches upstream of the knickpoint, including the cascade-pool reaches and the forced boulder step and pool near station 8+95, have an overall slope of 6.75%. The slope of the cascade-pool reach upstream of station 8+95 has a slope of 6.23%. Between the knickpoint and Cecilville Road, the channel has an overall slope of 6.3%.

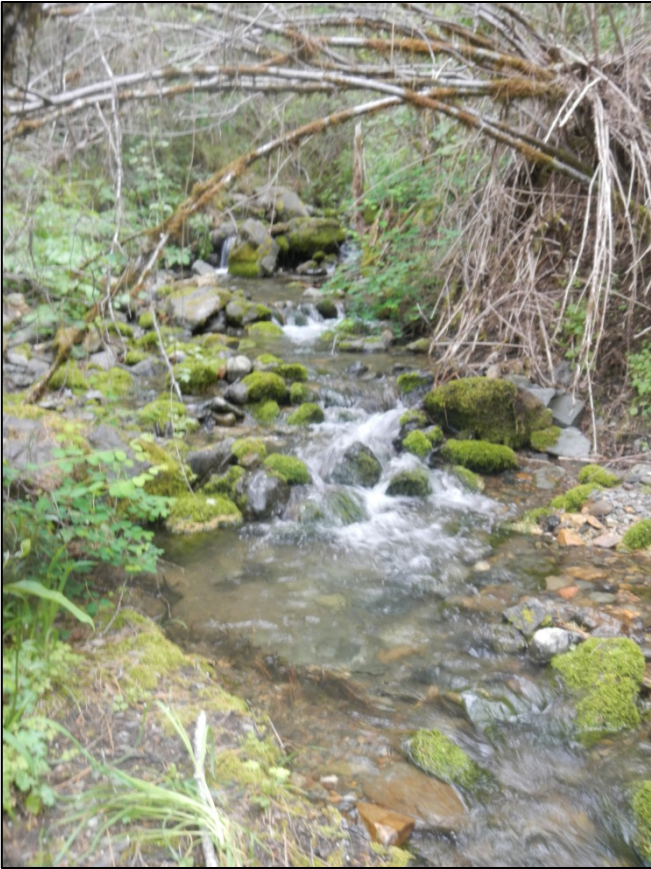
Figure 5. Typical cascade-pool channel reach in Hotelling Gulch.

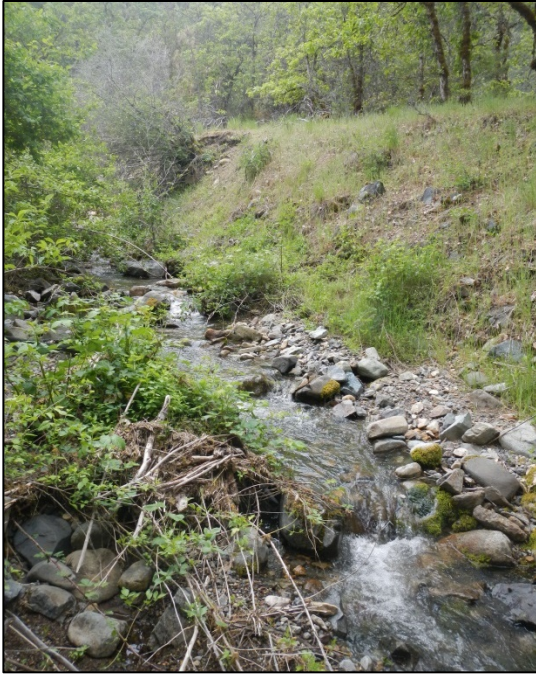
Figure 7. Photograph of the existing alignment of Hotelling Gulch (looking upstream).

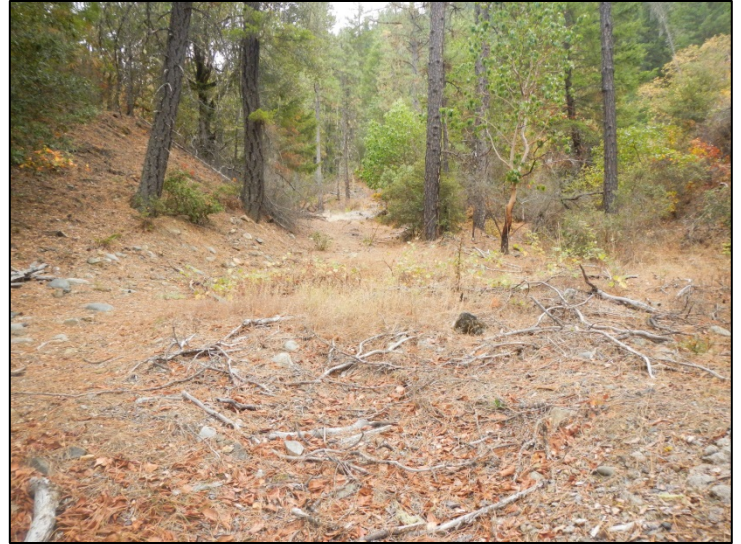
Figure 8. Remnants of stream valley along the historical alignment of Hotelling Gulch, looking downstream to Cecilville Road.

The historical alignment of Hotelling Gulch is located further to the west of the channel current alignment. There is little evidence of the historic channel thalweg upstream of Cecilville Road except the broader stream valley through which it flowed, as shown in Figure 8. Downstream of Cecilville Road, a perennial groundwater-fed channel persists in the presumed location of the historical alignment.

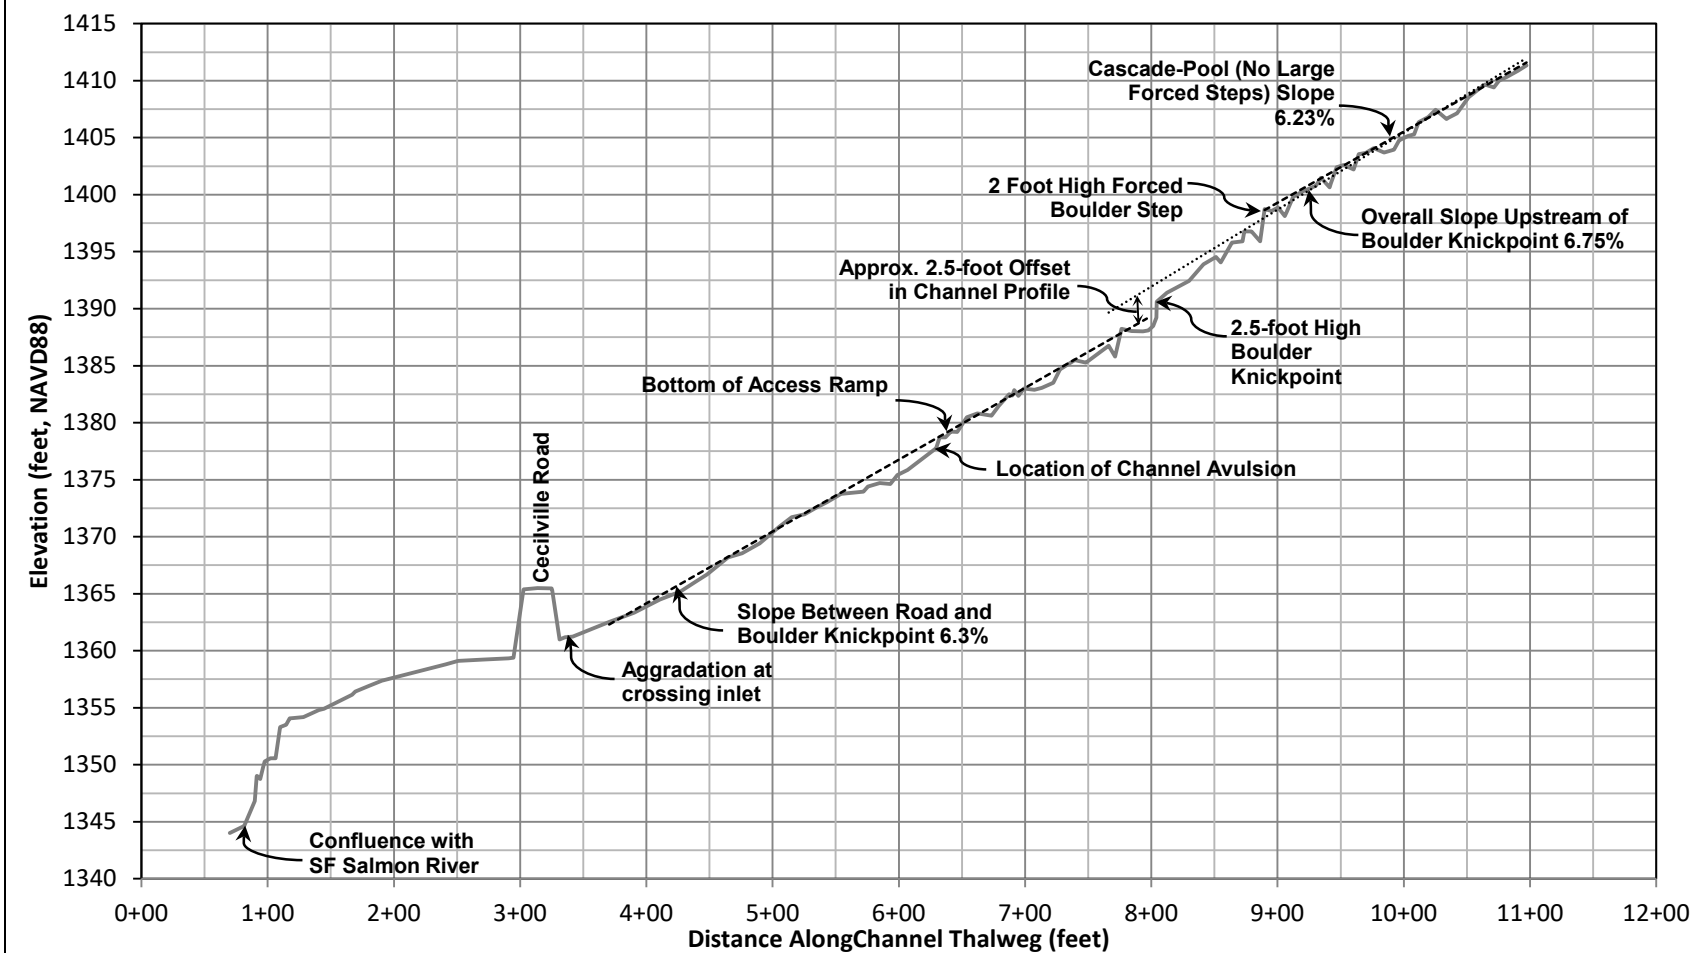
Hotelling Gulch Eastern Thalweg Profile (Existing Conditions)

Figure 9. Thalweg profile of Hotelling Gulch along its current alignment, from the river to approximately 500 feet upstream of the avulsion location.

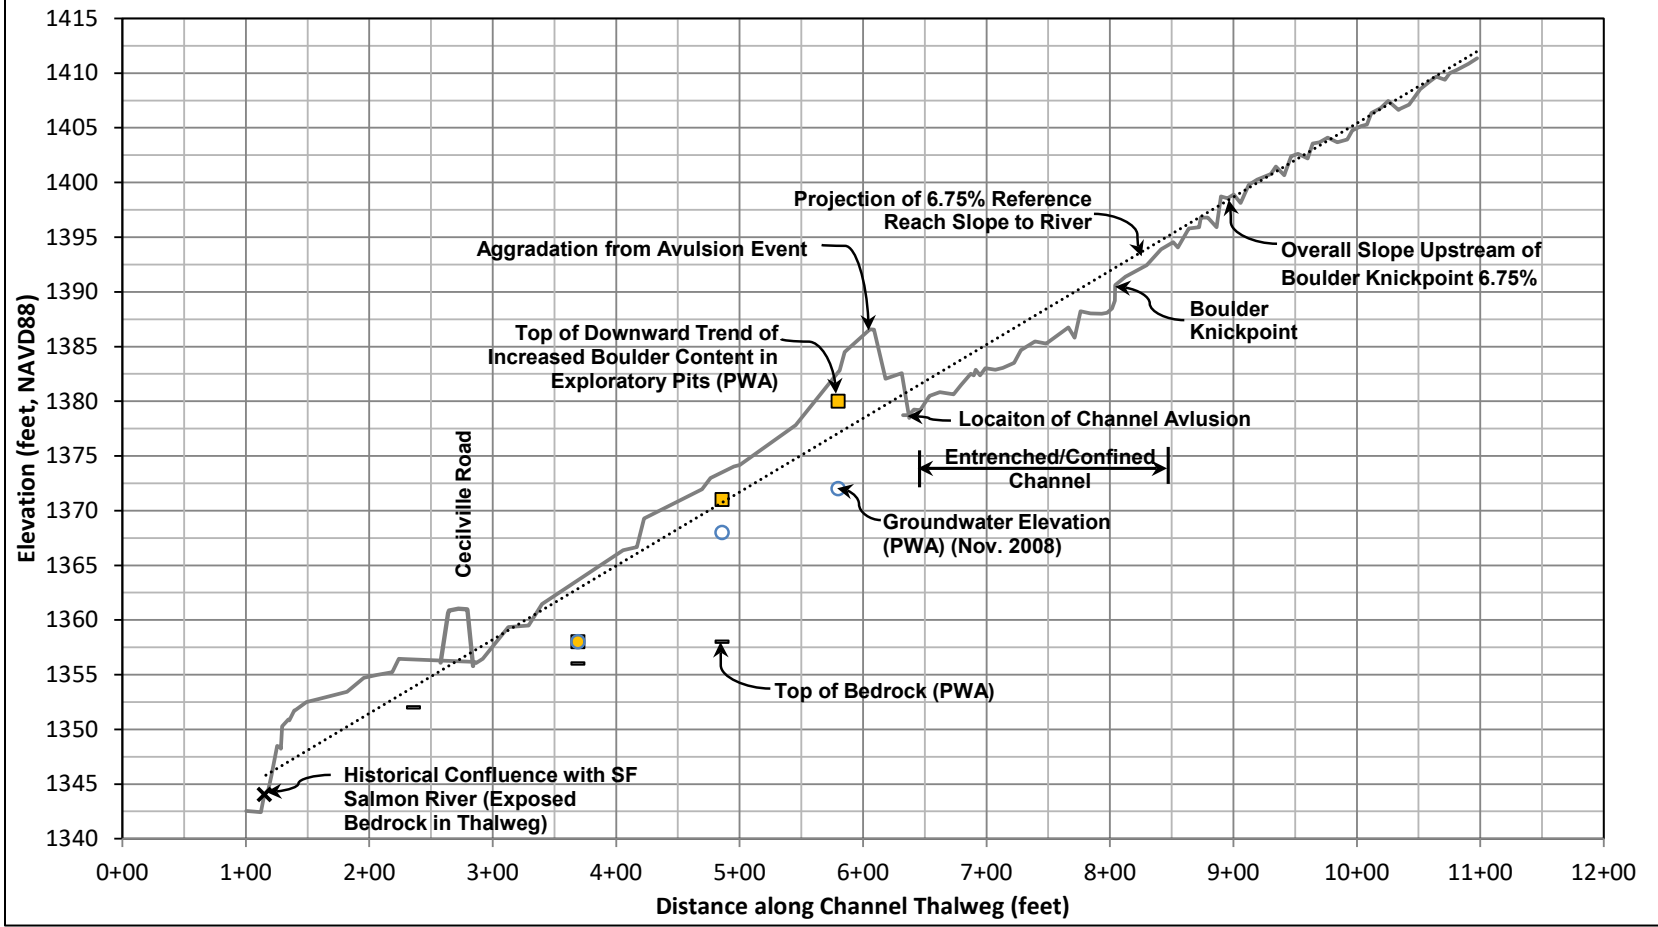
Hotelling Gulch Western Alignment (Existing and Proposed Conditions)

Figure 10. Thalweg profile along the historical (western) alignment of Hotelling Gulch, from the river to approximately 500 feet of the avulsion location.

In Figure 10, the 6.75% overall channel slope upstream of the boulder knickpoint is shown projected downstream to the confluence with the river. Where the projected profile intersects the river is coincident with the surveyed elevation of the bedrock spanning the channel bottom near the river confluence. Also shown on Figure 10 are elevations from PWA's test-pits where the size and frequency of larger boulders increased in the test pits. These boulders appear to be similar in size to the upstream channel reach. The coincidence of the projected stream profile from upstream to the surveyed bedrock/alluvium contact point at the confluence, with the presence of larger boulders, suggests that the projected profile line is close to the historical thalweg of the stream channel prior to the avulsion.

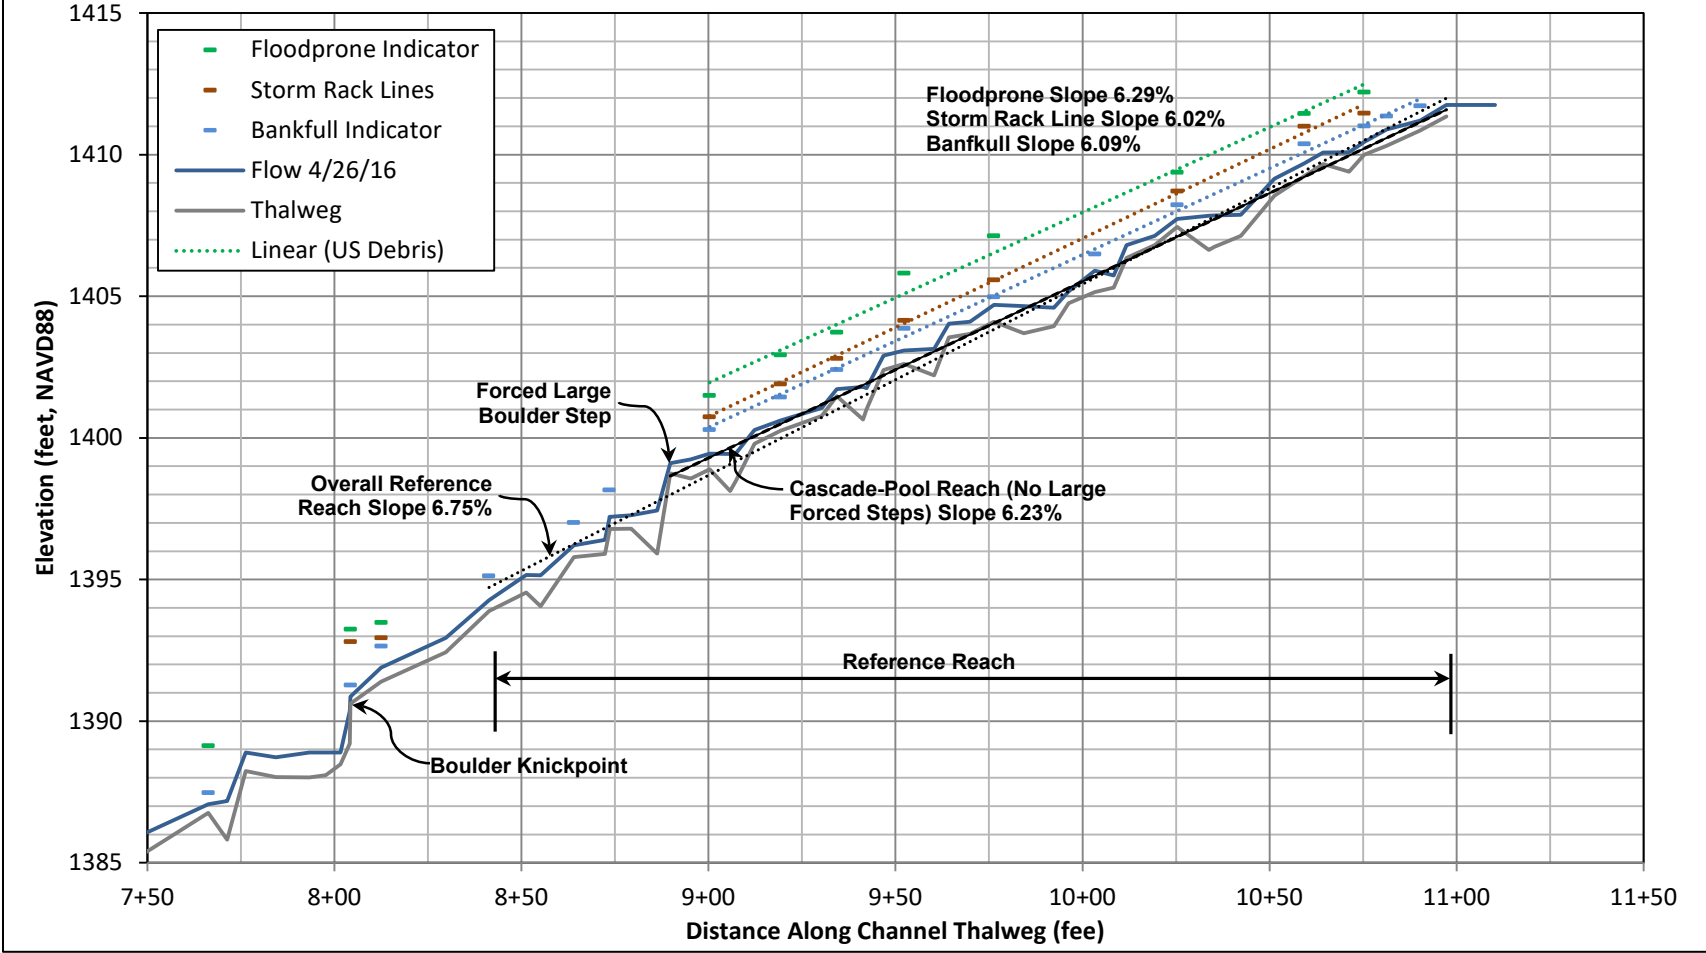
Hotelling Gulch Reference Reach Slope Analysis

Figure 12. Profile of reference reach approximately 200 feet upstream of the proposed channel realignment in Hotelling Gulch.

Figure 12 presents a detailed profile of the reference reach. The reference reach, including both the cascade-pool reaches and the forced boulder step-pool near station 8+95 has an overall slope of 6.75%. The localized slope of the cascade-pool reach, which has forced boulder step at station 8+95 as its base-level control, has a slope of 6.23%. The overall slopes of the surveyed bankfull, floodprone and storm rack lines along the cascade-pool reach have similar slopes as the thalweg slope in this reach, supporting the estimation of the localized slope.

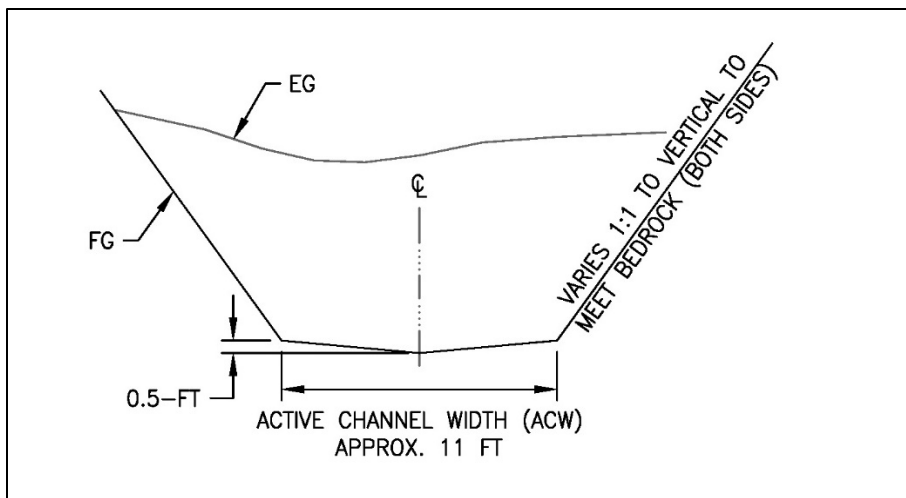
Figure 15. Typical design cross section for the realigned within the bedrock confluence area.

Within the bedrock-bounded area at the confluence of Hotelling Gulch with the river, the channel cross section was simplified to include an 11-foot active channel width, gentle to and steep side slopes, as show in Figure 15. An 11-foot bottom width is recommended to maintain flow and sediment transport continuity through the confluence area and into the River. This is expected to reduce the amount of sedimentation that may occur at the confluence. The actual width of the channel bottom and side slopes is expected to vary in the field with the location and degree that the bedrock can be economically excavated.

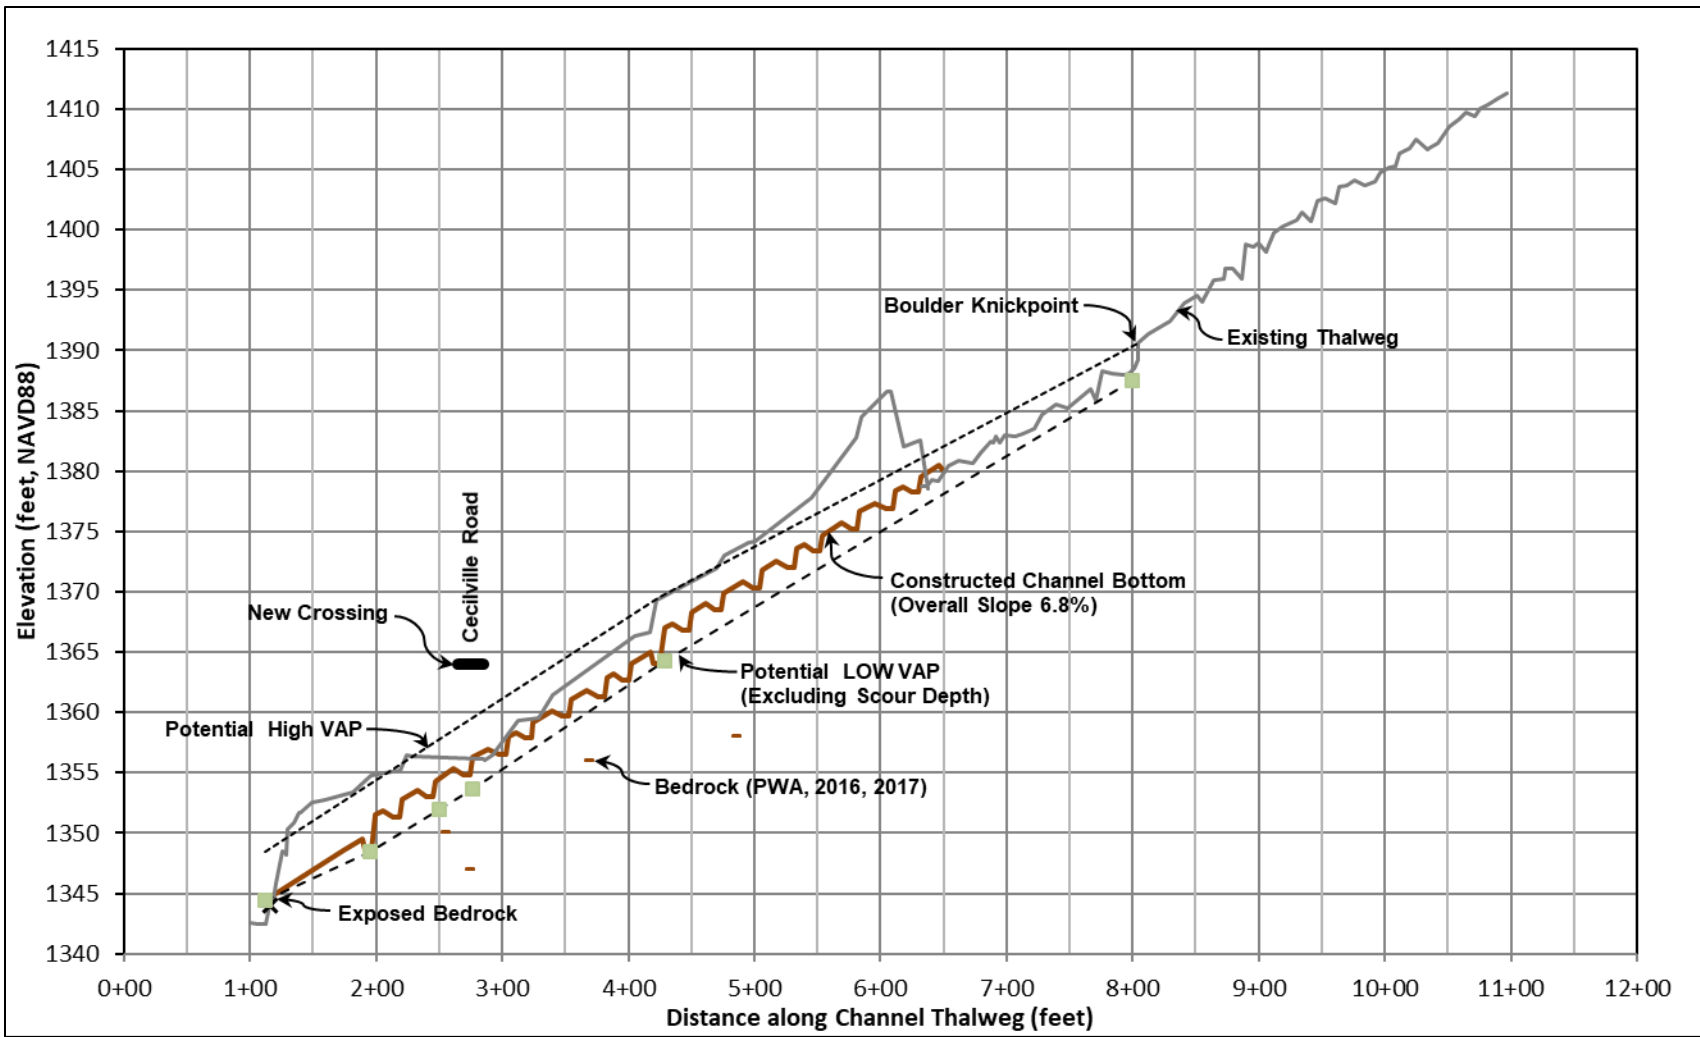
Figure 18. Channel thalweg profile of Hotelling Gulch showing the existing and design channel, the extents of the predicted high and low vertical adjustment profiles (VAP) along the project area.

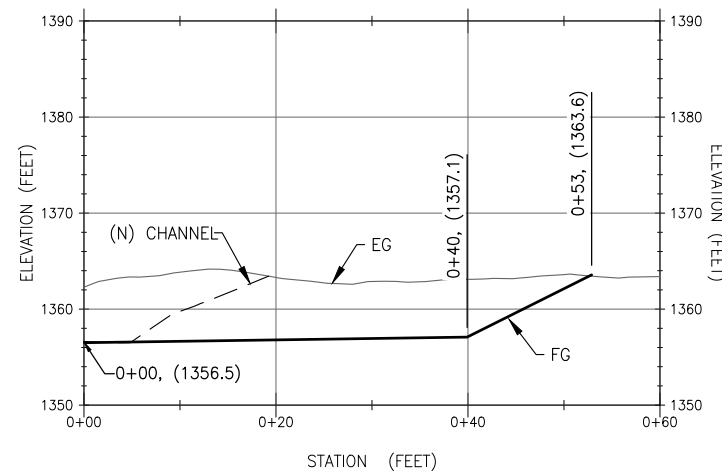
PROFILE
US ALCOVE ALIGNMENT

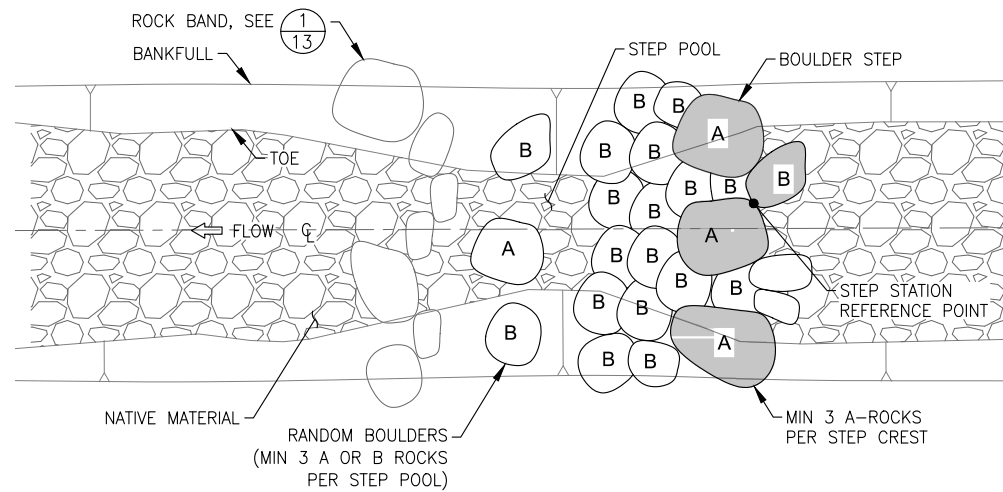
2 **STEP / POOL**
TYPICAL NTS

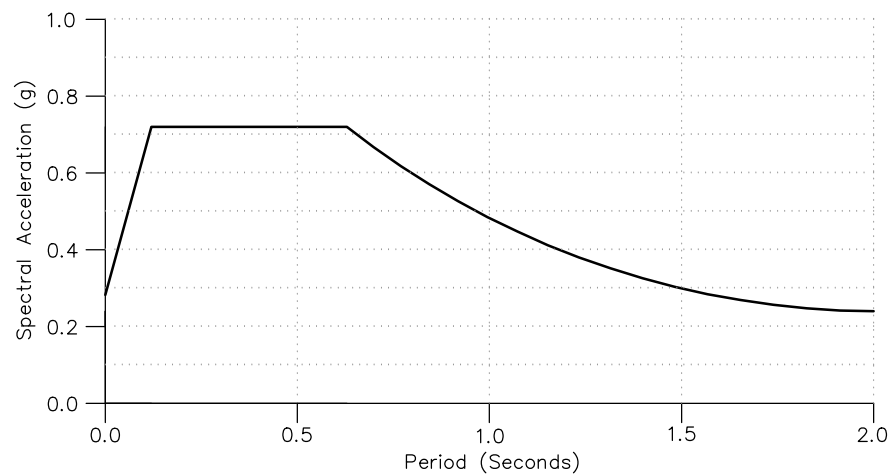
ACCELERATION RESPONSE SPECTRA CURVE

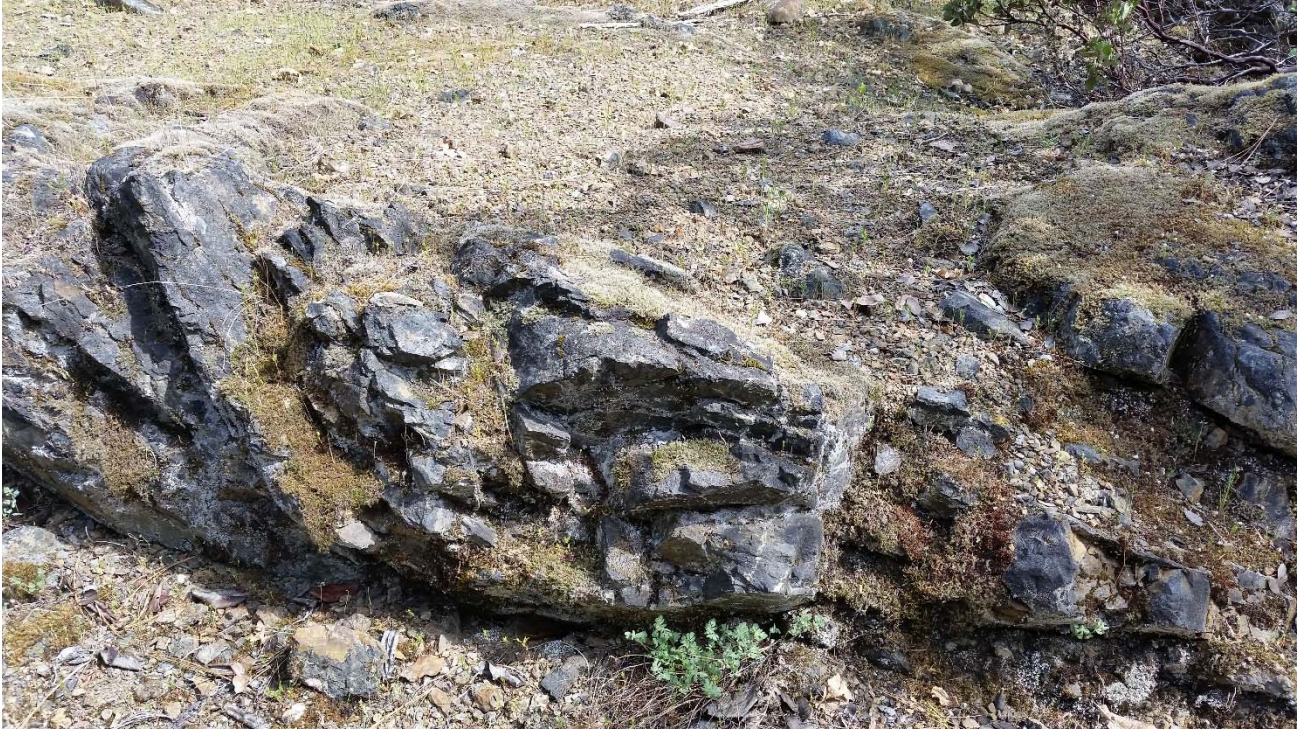
Photo 1. Bedrock outcrop of the Hayfork terrane within the project vicinity.

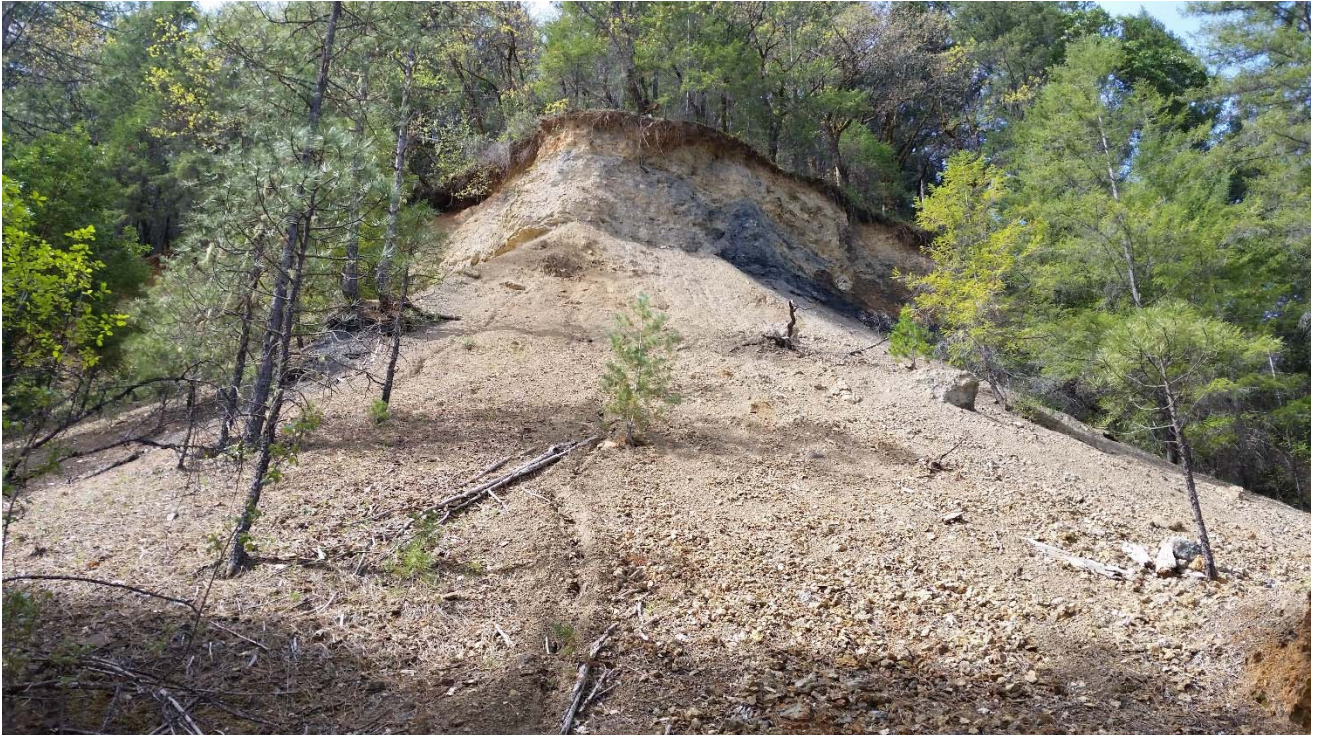
Photo 2. Hydraulically mined hillslope above (south) the HGFCDP area.

The first available photo set (1944) indicates a significant area (~2.5 acres) of ground disturbance approximately 800 feet south, upslope from the current Hotelling Gulch road crossing (Map 3; Photo 2). Similarly, a large (~5 acres), terraced surface with high cut-slopes appears approximately 1,000 feet east of the HGFCDP area (Map 3; Photo 3). Aerial photo and field-based geomorphic evidence show direct hydrologic connection of hydraulically mined deposits into Hotelling Gulch from these areas (Map 3). Large placer deposit piles appear just below the mined areas and extend across the alluvial fan surface in the project area (Photo 4). Based on the extent of revegetation visible on the 1944 photos, major hydraulic placer mining activity appears to have ceased prior to the 1944 photo year.

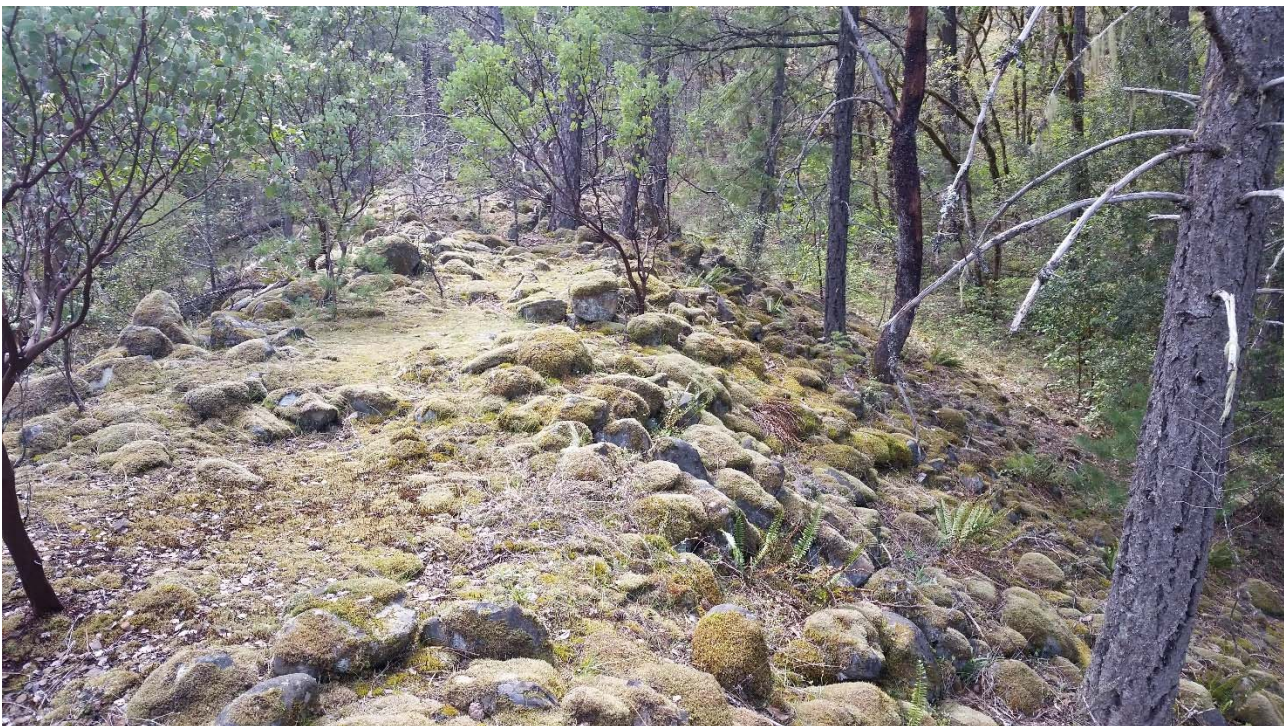
Photo 3. Terraced surface with high cut-slopes. Aerial photo evidence suggests this area was hydraulically mined prior to 1944 and placer deposits were conveyed directly into Hotelling Gulch above the HGFCDP area.

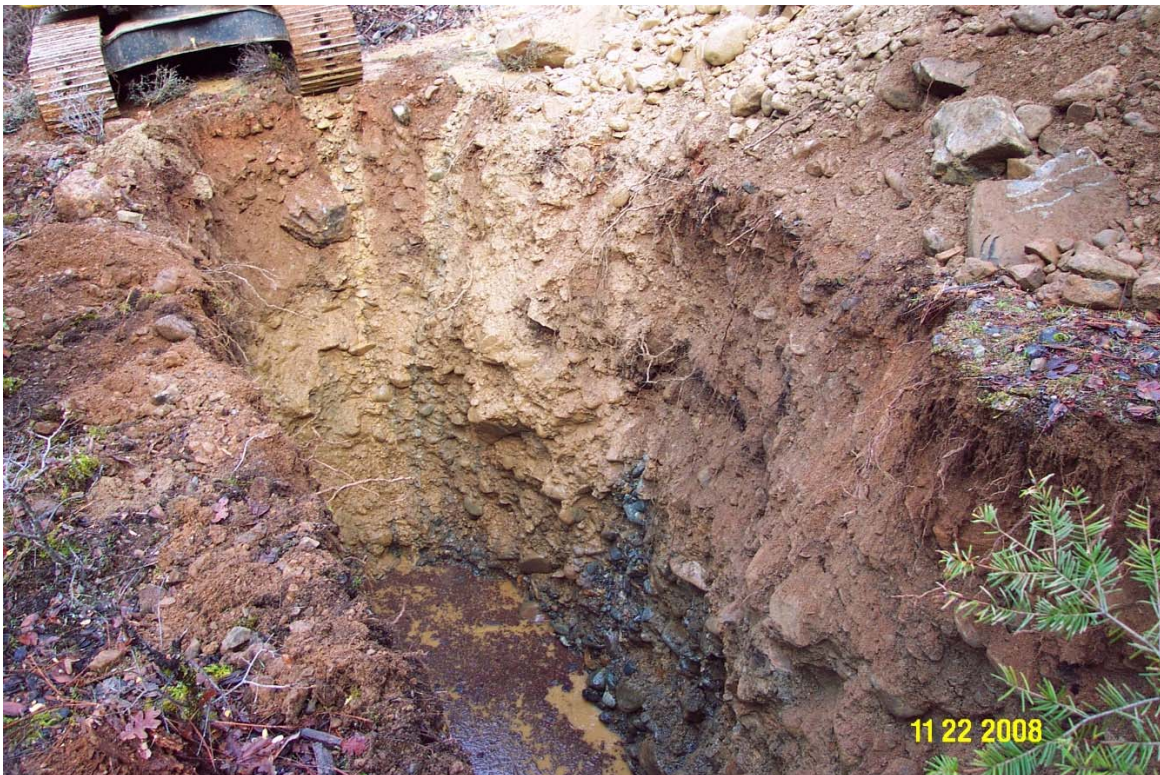
Photo 5. Excavation Test Pit # 6 showing typical stratigraphy; poorly sorted, heterogeneous alluvial deposits that have been reworked by hydraulic mining activities.

identified and ranged from approximately 4 feet below ground surface elevation in Test Pit 1 to over 12 feet in Test Pit 8. Prior to backfilling the test pits, the bedrock/alluvium contact, the water table surface elevation, and the test pit aerial extent were surveyed (Map 3; Figure 1, Photo 7). All of the observed deposits overlying bedrock were unconsolidated and are considered to be anthropogenic re-worked, cohesion-less alluvial/colluvial deposits (Figure 1; Photos 5 & 6).

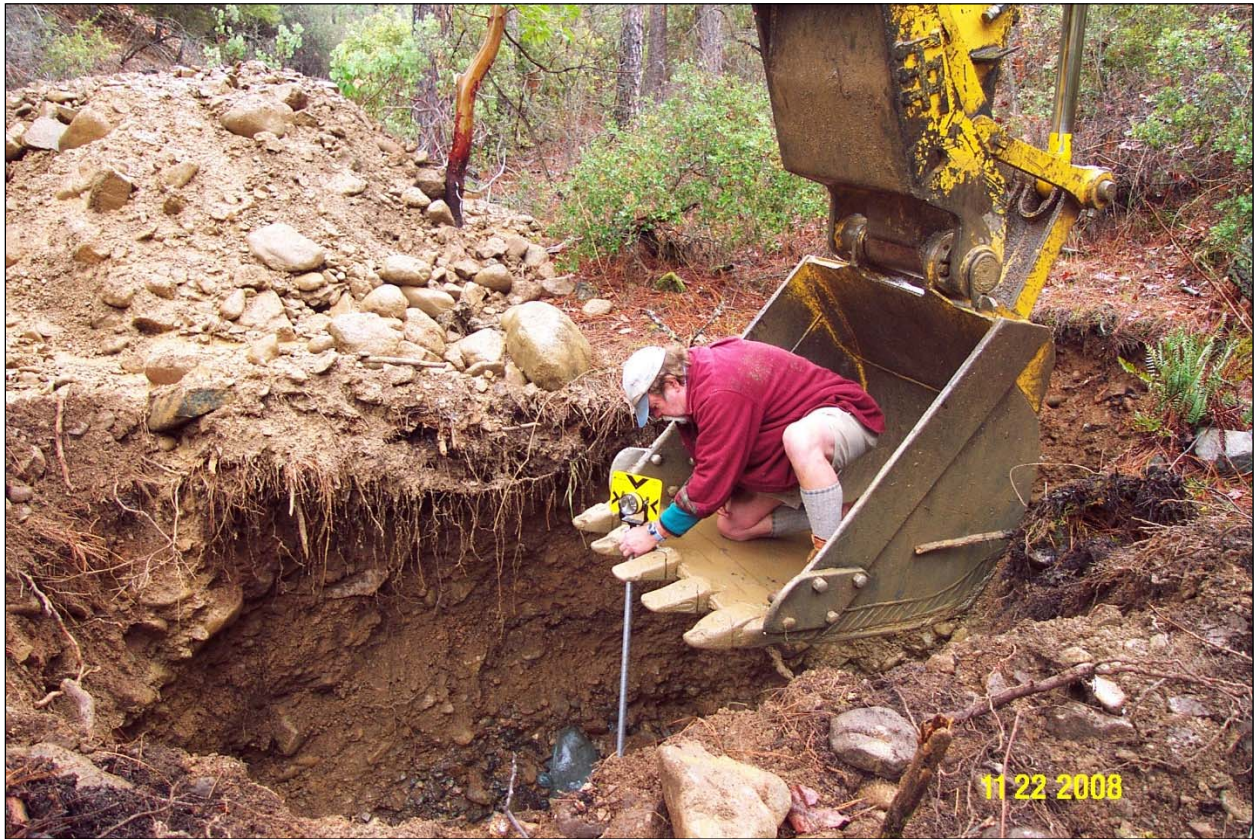
Photo 6. Excavation Test Pit # 7 showing similar stratigraphy.

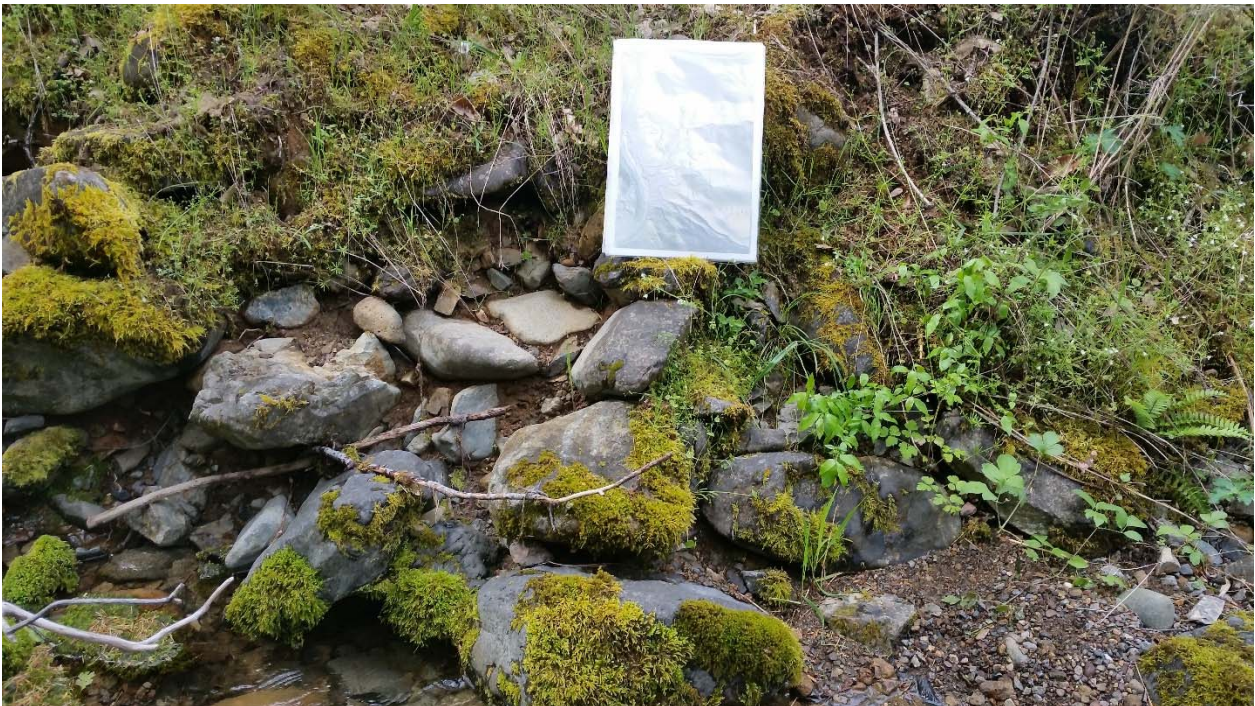
Photo 7. Surveying depth to bedrock and the water table surface in Excavation Pit # 6.

In 3 of the 4 test pits, depth to bedrock was clearly identified and ranged from approximately 4 feet below ground surface elevation in Test Pit 1 to over 18 feet in Test Pit 7 (Photo 7). In Test Pit 8, the excavator reached 18 feet below the ground surface elevation and either the bedrock was deeper than the excavator's workable reach, or the high rate of groundwater inflow obscured visibility and it was not possible to determine if bedrock had been reached. The slope of the bedrock contact observed between test pits 1 and 7 averages less than 1% (Figure 2). In all test pits, the seasonal water table surface was

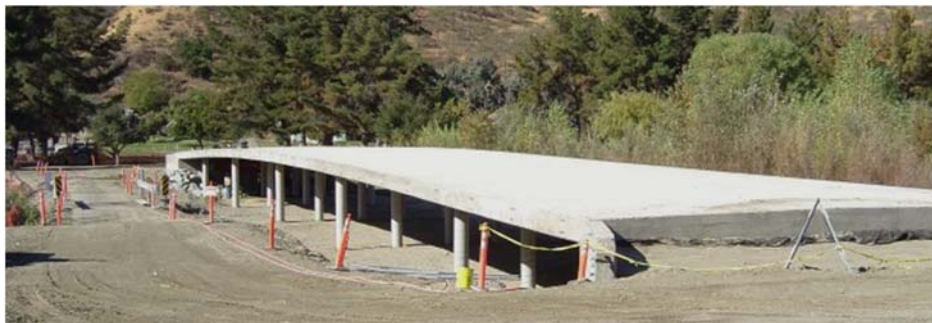
Typical Reinforced Concrete Slab Bridge during Construction

Slab Bridge Superstructure Type: Solid slab bridges are relatively simple superstructures that are easy to construct and work well for short spans, where they are typically the most cost effective type. Based on a span length of less than twenty feet, the preferred bridge type is a simply supported slab bridge. A slab bridge will require the thinnest cross section and least amount of profile adjustment of the existing roadway grade. It is also the most cost effective type for this span length.

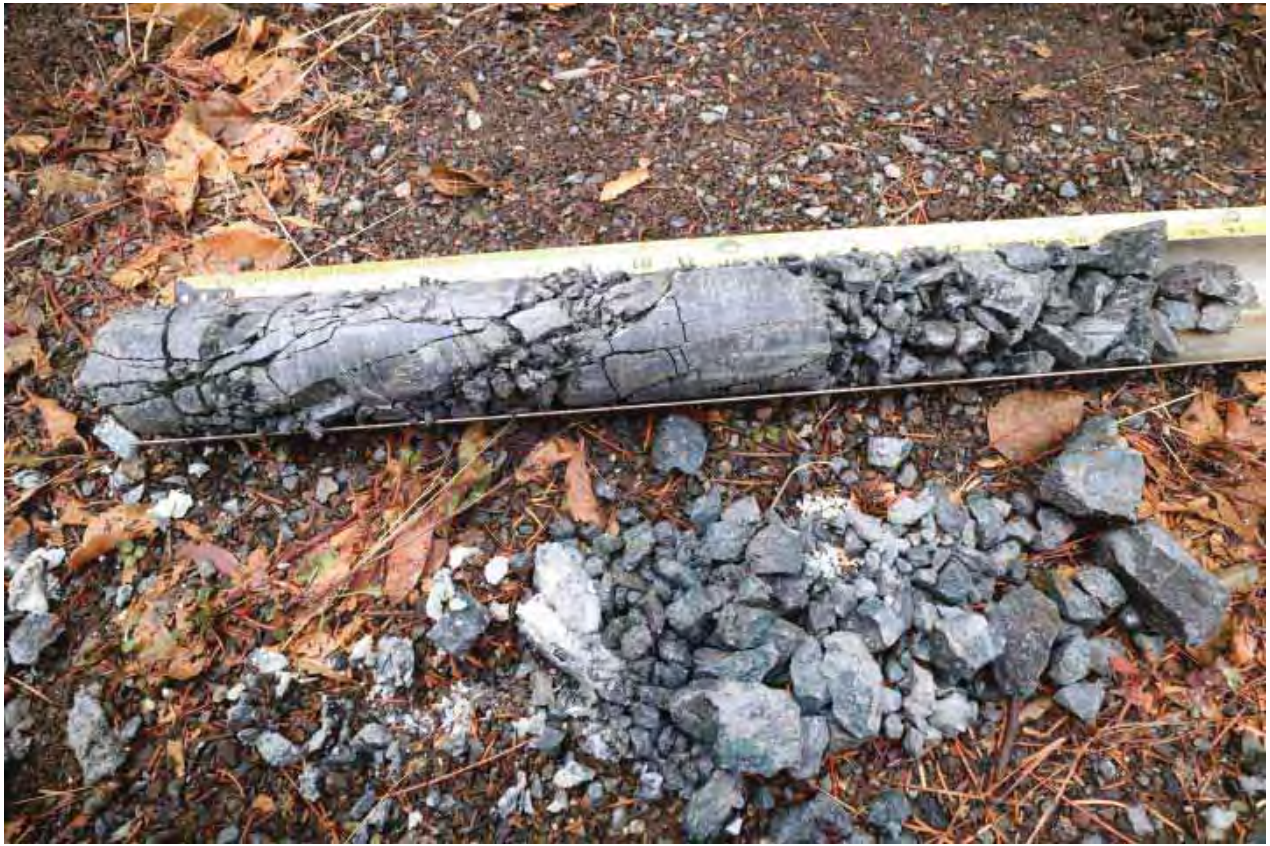
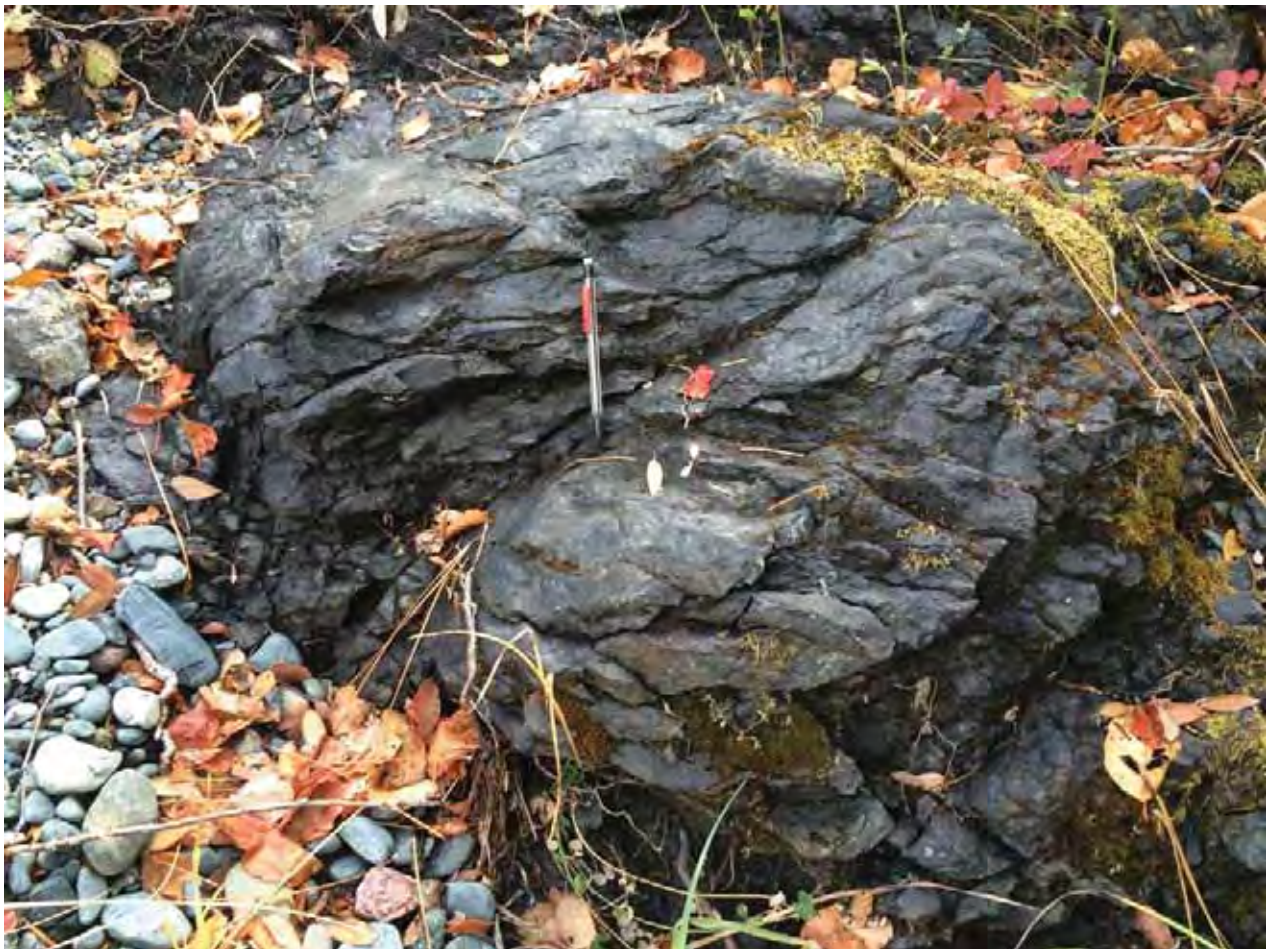
Figure 1. photographs showing typical bedrock characteristics. The top photo shows how the bedrock sample was observed in a typical core retrieval. The lower photo shows how the bedrock is exposed at the natural ground surface locally. The lower photo location is along the left bank of the South Fork Salmon River near its confluence with Hottelling Creek.
