**Basis of Design Report for the
Restoration of Hotelling Gulch
Cecilville, Siskiyou County, California**

October 2018

Michael Love & Associates

Basis of Design Report for the Restoration of Hotelling Gulch

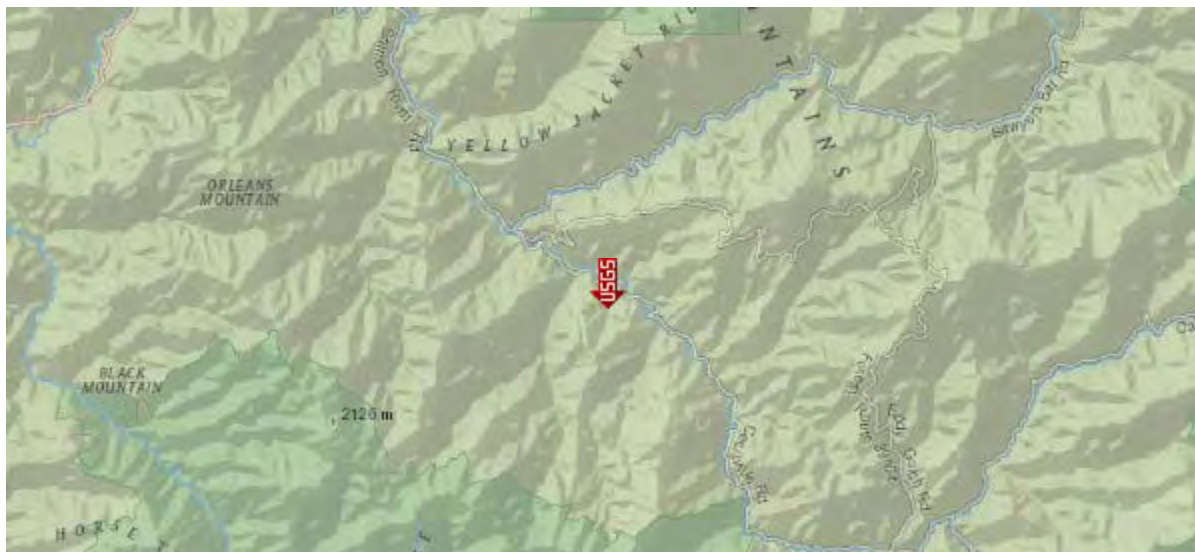
USGS-Provided Output

$S_S = 0.979 \text{ g}$ $S_{MS} = 1.085 \text{ g}$ $S_{DS} = 0.723 \text{ g}$
 $S_1 = 0.444 \text{ g}$ $S_{M1} = 0.690 \text{ g}$ $S_{D1} = 0.460 \text{ g}$
